Cold repairs to remedy the damages caused by welding

ID: 9165

Industry: Steel & Metal Processing
Application: TCC-Tanks and Chemical Containment Areas
Substrate: Carbon steel
Products: Belzona 1391T, Belzona 1511 (Super HT-Metal)

Customer Location: Germany
Application Date: October 2023

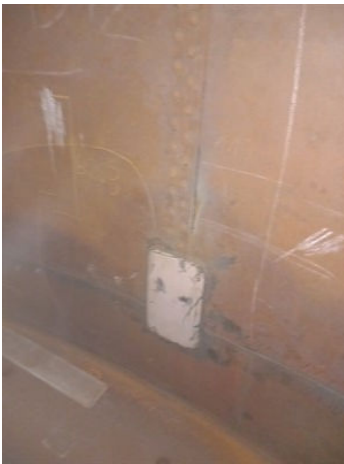
Small metal plate welded on the tank

Belzona 1511 was required to create a taper between the welded plates and the existing tank structure, before being overcoated using Belzona 1391T. The small circular plates were used by the contractor to plug holes where they pour a low cost mortar to fill the void.

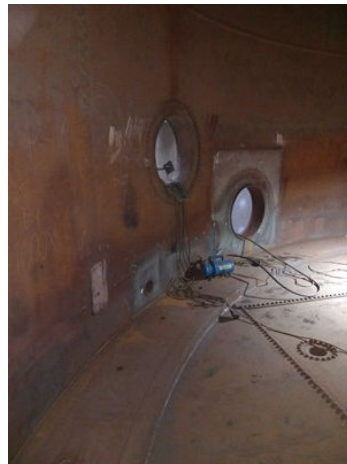
General View of the tank

Around the riveted sections, Belzona 1511 was used in conjunction with the reinforcing mesh Belzona 9341, before overcoating using Belzona 1391T.

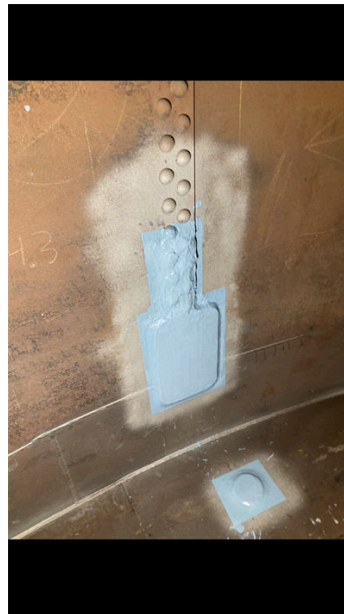
Localised repair

Grit blasting of the section in order to achieve the required profile and cleanliness, before applying the paste grade Belzona 1511. Whilst in the overcoating window, Belzona 1391T was applied in 2 coats of 450 microns.

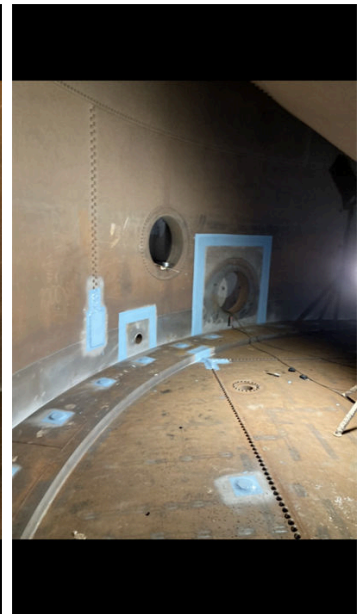
Section of the tank completed
