BELZONA REPAIRS AND PROTECTS DEMINERALISATION CHANNELS

Application: TCC-Tanks and Chemical Containment Areas

Customer Location: Nuclear Power Plant, Lancashire, UK

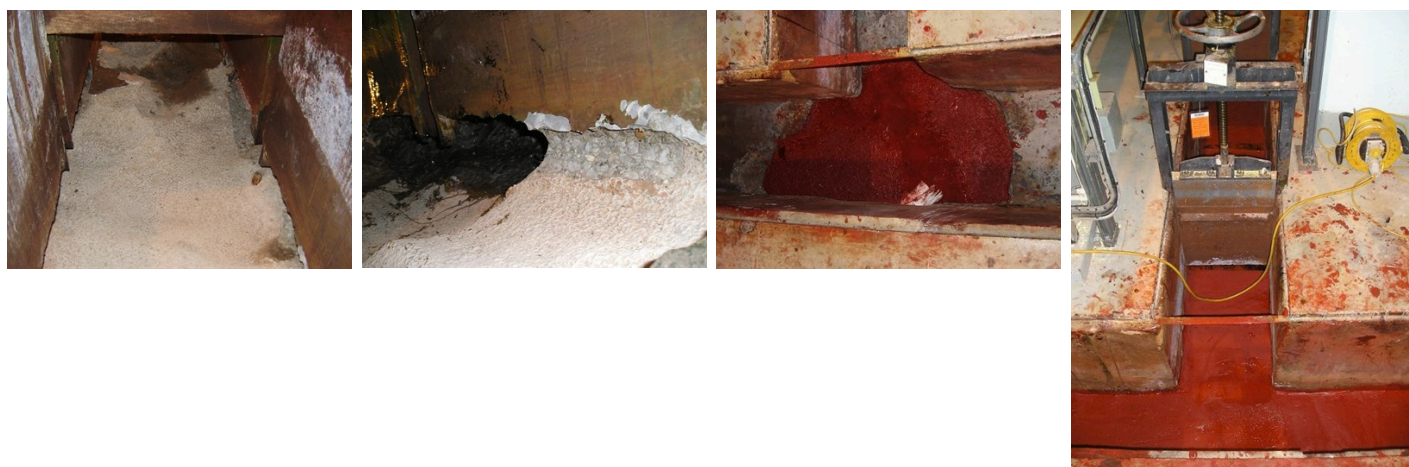
The concrete channel was deteriorated from the acid. A previously applied protective coating had failed and allowed the concrete substrate to be attacked. This caused severe holes and damage to the channels.

- * Damaged concrete substrate ,
- * Close up of damaged reinforced concrete substrate ,
- * Filling in the prepared holes using Belzona 4181 ,
- * Completed channel ,

The application was carried out in accordance with Belzona Know-How System Leaflet TCC-9.
