Belzona delivers on awkward roof

ID: 9171

Application: RPA-Roof Problem Areas

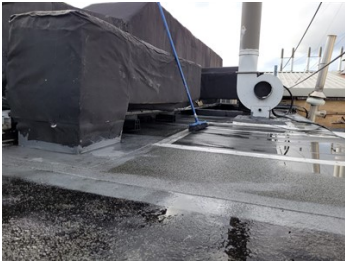
Bolted assets and standing water

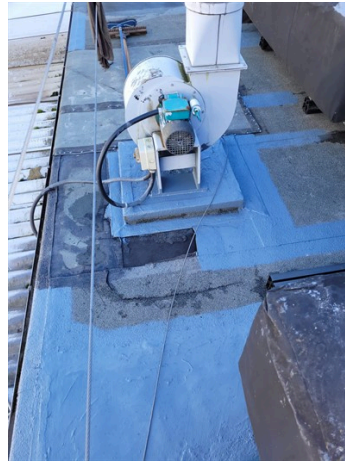
Geometric challenges overcome using Belzona 3000 series

The roof was thoroughly cleaned prior to applying conditioner to some areas. After this, 2 x coats of the Belzona 3131 (WG membrane), along with the appropriate Belzona 9351 (Reinforcing Tape).

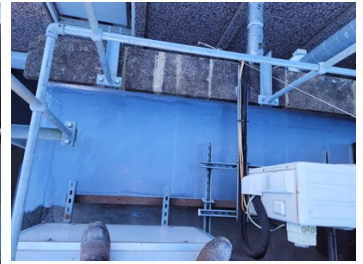
Fully encapsulated in a short time with little difficulty
