Belzona chosen for Rope Access repairs to huge concrete chimney

ID: 9175

Application: WPA-Wall Problem Areas

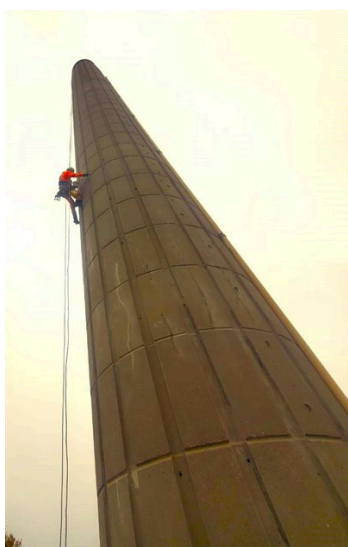
Spalling concrete was identified on a 300' concrete chimney during a rope access inspection. The concrete was unstable in certain areas and the Rope Access company's report highlighted numerous repair areas to make the structure safe and prevent falling debris from height

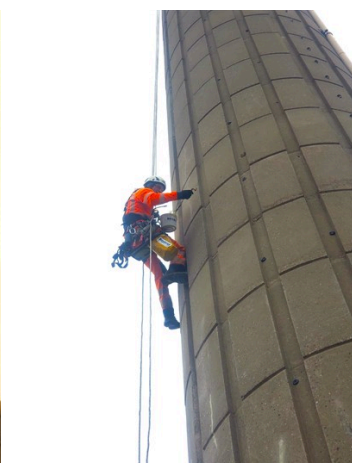
The work and scope made this impossible to shutter or to scaffold

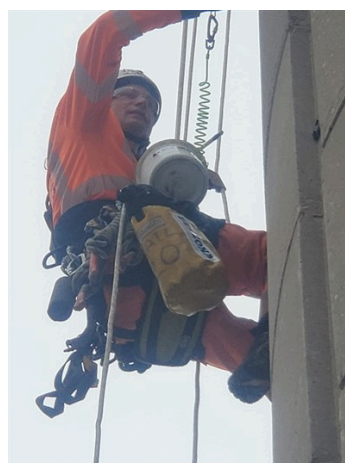
Rope access and a lightweight repair polymer was the most preferential choice due to access difficulties

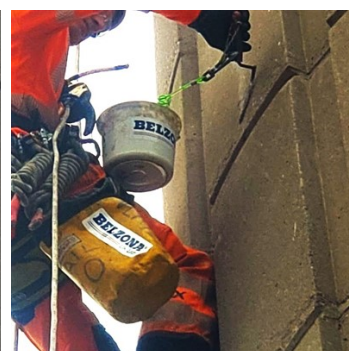
Completing the works

A rope access company who have worked with us many times, safely completing this difficult work
