Belzona chosen for Rope Access repairs to huge concrete chimney

ID: 9175

Application: WPA-Wall Problem Areas

Substrate: Concrete

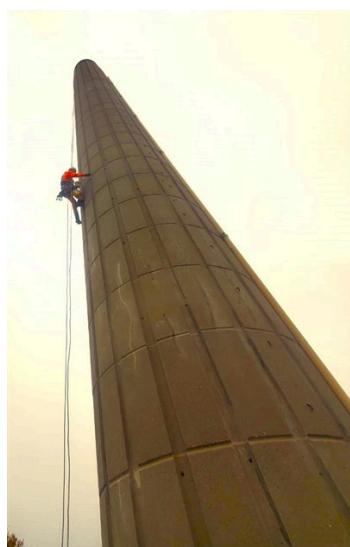
Spalling concrete was identified on a 300' concrete chimney during a rope access inspection. The concrete was unstable in certain areas and the Rope Access company's report highlighted numerous repair areas to make the structure safe and prevent falling debris from height

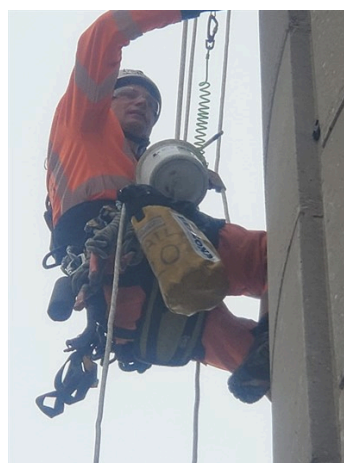
Rope access and a lightweight repair polymer was the most preferential choice due to access difficulties

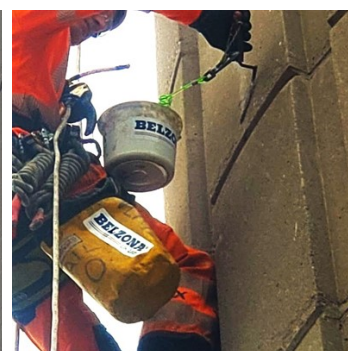
Completing the works

A rope access company who have worked with us many times, safely completing this difficult work
