Internal Floating Roof (IFR) Repair - Belzona Florida

Industry: General Industry
Application: TCC-Tanks and Chemical Containment Areas
Substrate: Aluminum
Products: Belzona 1121 (Super XL-Metal)

Customer Location: Port Canaveral, Florida
Application Date: November 2023

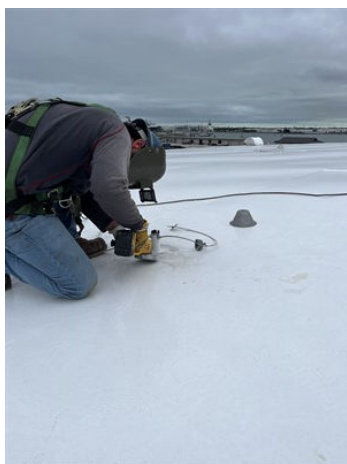
Area being prepped.

Standard surface preparation through the use of an angle grinder and a carbide grinding wheel.

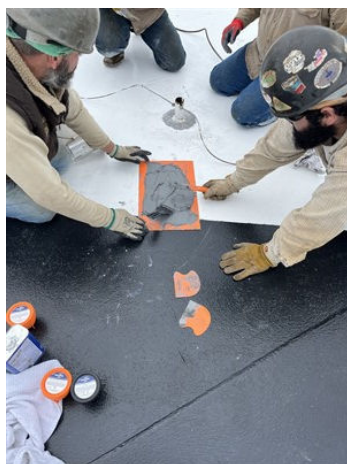
1121 product being mixed.

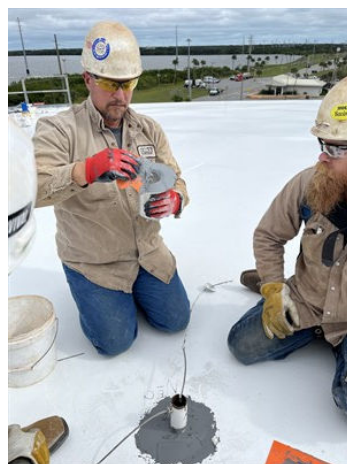
1121 being applied to the piece that will be bonded.

They needed an adhesive that they could trust to bond the new aluminum pieces in place. Belzona 1121 was chosen for its outstanding performance characteristics, ease of use and extended working life

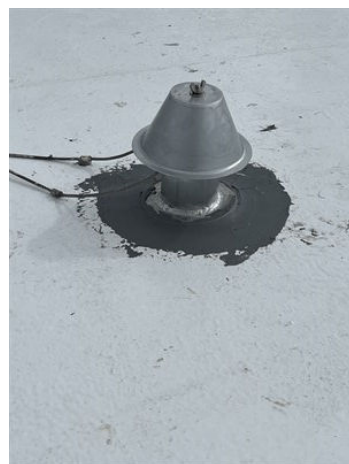
Finished application.

Belzona 1121 allowed the customer to replace nearly 40 units and just a few hours.
