Internal Floating Roof (IFR) Repair - Belzona Florida

ID: 9177

Customer Location: Port Canaveral, Florida
Application Date: November 2023

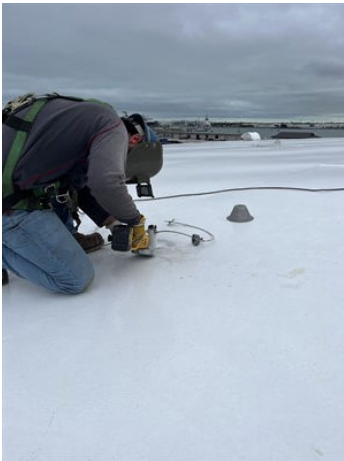
Area being prepped.

Standard surface preparation through the use of an angle grinder and a carbide grinding wheel.

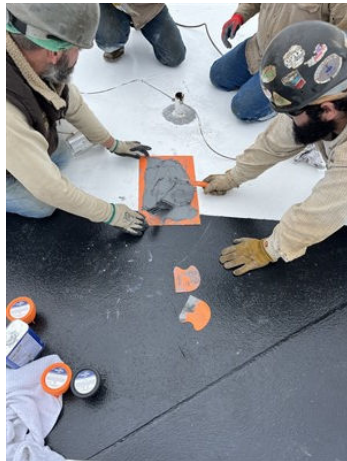
1121 product being mixed.

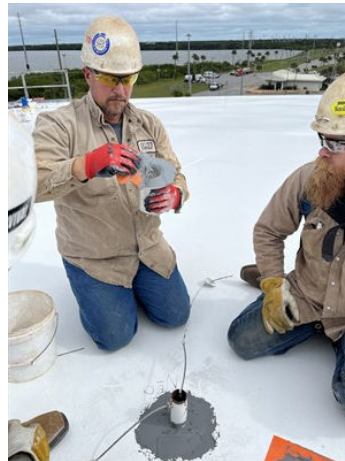
1121 being applied to the piece that will be bonded.

They needed an adhesive that they could trust to bond the new aluminum pieces in place. Belzona 1121 was chosen for its outstanding performance characteristics, ease of use and extended working life

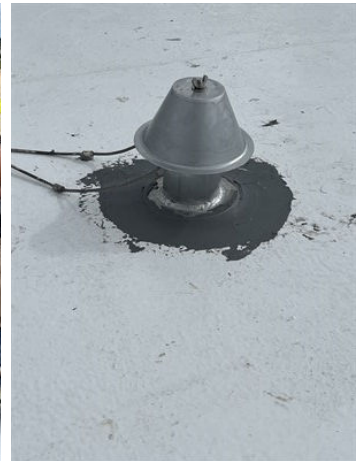
Finished application.

Belzona 1121 allowed the customer to replace nearly 40 units and just a few hours.
