Internal Floating Roof (IFR) Repair - Belzona Florida

ID: 9177

Customer Location: *Port Canaveral, Florida*
Application Date: *November 2023*

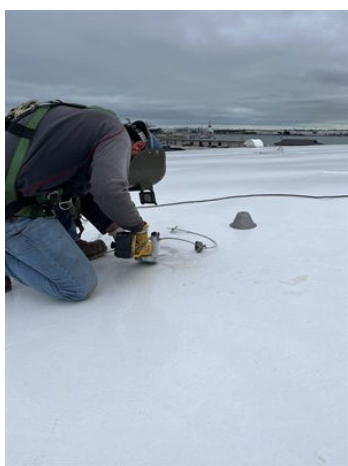
Area being prepped.

Standard surface preparation through the use of an angle grinder and a carbide grinding wheel.

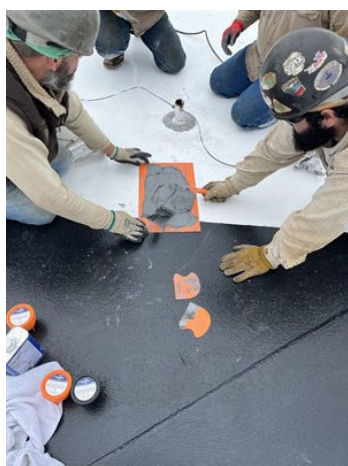
1121 product being mixed.

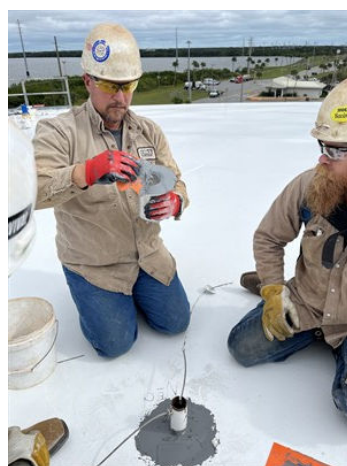
1121 being applied to the piece that will be bonded.

They needed an adhesive that they could trust to bond the new aluminum pieces in place. Belzona 1121 was chosen for its outstanding performance characteristics, ease of use and extended working life

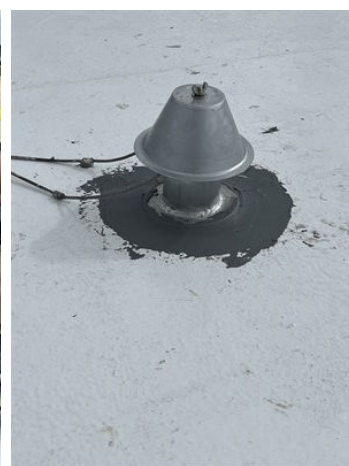
Finished application.

Belzona 1121 allowed the customer to replace nearly 40 units and just a few hours.
