Belzona Trials New SF6 Leak Solution to Seal the Deal.

Industry: Power
Application: VPF-Valves, Pipes and Fittings
Substrate: Aluminum
Products: Belzona 1981 (SuperWrap II), Belzona 7311

Customer Location: North East, United Kingdom
Application Date: September 2023

Electric Switch Gear flange within a Power Distribution Substation.

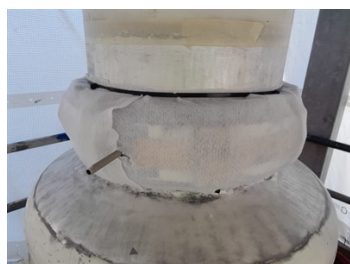
SF6 flange following surface preparation to SSPC-SP11, installation of the Backing Rod, tape, Redirection Nozzle & Breather Membrane.

The substrate (Aluminium) was first prepared in accordance with SSPC-SP11 Surface Preparation using an MBX (using a Stainless Steel wheel to prevent bi-metallic contamination). Once prepared, a backing-rod was applied behind the flange bolts and tape was applied over the bolts themselves (this prevents Belzona from adhering to them and allows a smoother surface transition). A Breather Membrane was applied around the circumference of the flange encapsulating it in its entirety, a Redirection Nozzle was also fitted to channel the leaking gas. Belzona 7311 was then applied to seal the membrane prior to the application of the impregnated Belzona 9341 (Reinforcement Sheet). The newly applied Belzona 7311 was then wetted out using Belzona 1981 (Winter Grade) SWII Resin prior to the application of 5 x wraps of Belzona 9371 (SWI Reinforcement Sheet) forming 10-layers (due to the 50% overlap). This was then left to polymerise (generating a slight self-curing exotherm) prior to a final encapsulating layer of Belzona 7311. The application required approximately 6L of Belzona 7311 & 5L of Belzona 1981. The application was carried out in accordance with a modified version of Belzona System Leaflet VPF-12.
