# Belzona Trials New SF6 Leak Solution to Seal the Deal.

**Industry:** Power  
**Application:** VPF-Valves, Pipes and Fittings  
**Substrate:** Aluminum  
**Products:** Belzona 1981 (SuperWrap II), Belzona 7311

**Customer Location:** North East, United Kingdom  
**Application Date:** September 2023

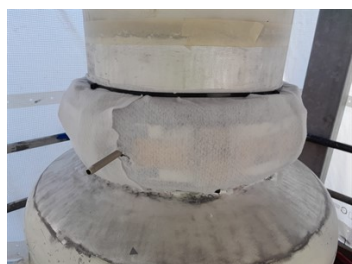
SF6 flange following surface preparation to SSPC-SP11, installation of the Backing Rod, tape, Redirection Nozzle & Breather Membrane.

The substrate (Aluminium) was first prepared in accordance with SSPC-SP11 Surface Preparation using an MBX (using a Stainless Steel wheel to prevent bi-metallic contamination). Once prepared, a backing-rod was applied behind the flange bolts and tape was applied over the bolts themselves (this prevents Belzona from adhering to them and allows a smoother surface transition). A Breather Membrane was applied around the circumference of the flange encapsulating it in its entirety, a Redirection Nozzle was also fitted to channel the leaking gas. Belzona 7311 was then applied to seal the membrane prior to the application of the impregnated Belzona 9341 (Reinforcement Sheet). The newly applied Belzona 7311 was then wetted out using Belzona 1981 (Winter Grade) SWII Resin prior to the application of 5 x wraps of Belzona 9371 (SWI Reinforcement Sheet) forming 10-layers (due to the 50% overlap). This was then left to polymerise (generating a slight self-curing exotherm) prior to a final encapsulating layer of Belzona 7311. The application required approximately 6L of Belzona 7311 & 5L of Belzona 1981. The application was carried out in accordance with a modified version of Belzona System Leaflet VPF-12.

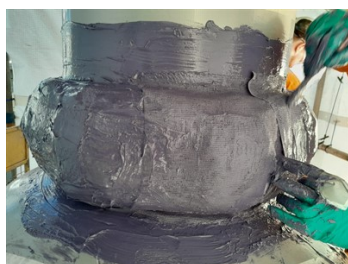
Wetting out of the Breather Membrane and vertical application of Reinforcement Sheets (Belzona 9341) using Belzona 7311.

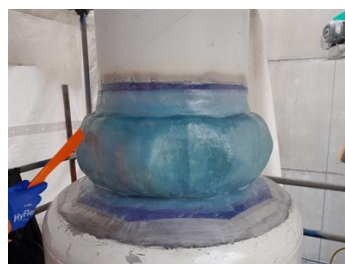
Post-application of 5x wraps of reinforcement sheet (Belzona 9371) and Belzona 1981 resin.

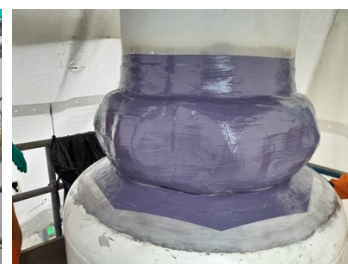
Final application after a further encapsulating layer of Belzona 7311.

Belzona conducted this application on a trial basis and had a remit to reduce the leak by at least a minimum of 80%. The application was undertaken within a 12-hour shift, and cost approximately £13,000, including all labour. The solution was classed as successful

after 3-months of service and is now being rolled out at other national substations.
