Belzona Trials New SF6 Leak Solution to Seal the Deal.

Industry: Power
Application: VPF-Valves, Pipes and Fittings
Substrate: Aluminum
Products: Belzona 1981 (SuperWrap II), Belzona 7311

Customer Location: North East, United Kingdom
Application Date: September 2023

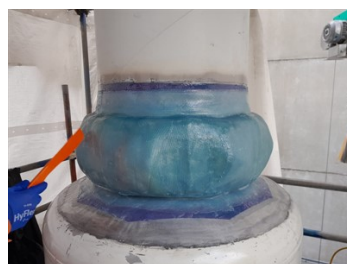
Post-application of 5x wraps of reinforcement sheet (Belzona 9371) and Belzona 1981 resin.

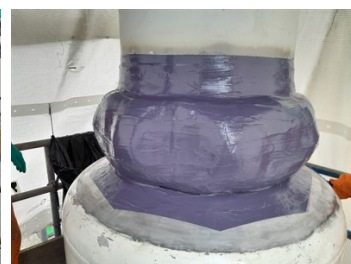
Final application after a further encapsulating layer of Belzona 7311.

Belzona conducted this application on a trial basis and had a remit to reduce the leak by at least a minimum of 80%. The application was undertaken within a 12-hour shift. The solution was classed as successful after 3-months of service and is now being rolled out
