Belzona Trials New SF6 Leak Solution to Seal the Deal.

Industry: Power
Application: VPF-Valves, Pipes and Fittings
Substrate: Aluminum
Products: Belzona 1981 (SuperWrap II), Belzona 7311

Customer Location: North East, United Kingdom
Application Date: September 2023

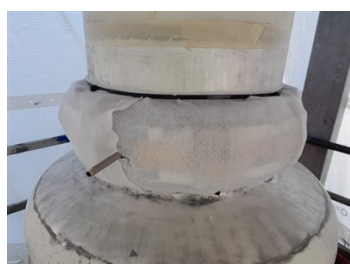
SF6 flange following surface preparation to SSPC-SP11, installation of the Backing Rod, tape, Redirection Nozzle & Breather Membrane.

The substrate (Aluminium) was first prepared in accordance with SSPC-SP11 Surface Preparation using an MBX (using a Stainless Steel wheel to prevent bi-metallic contamination). Once prepared, a backing-rod was applied behind the flange bolts and tape was applied over the bolts themselves (this prevents Belzona from adhering to them and allows a smoother surface transition). A Breather Membrane was applied around the circumference of the flange encapsulating it in its entirety, a Redirection Nozzle was also fitted to channel the leaking gas. Belzona 7311 was then applied to seal the membrane prior to the application of the impregnated Belzona 9341 (Reinforcement Sheet). The newly applied Belzona 7311 was then wetted out using Belzona 1981 (Winter Grade) SWII Resin prior to the application of 5 x wraps of Belzona 9371 (SWI Reinforcement Sheet) forming 10-layers (due to the 50% overlap). This was then left to polymerise (generating a slight self-curing exotherm) prior to a final encapsulating layer of Belzona 7311. The application required approximately 6L of Belzona 7311 & 5L of Belzona 1981. The application was carried out in accordance with a modified version of Belzona System Leaflet VPF-12.

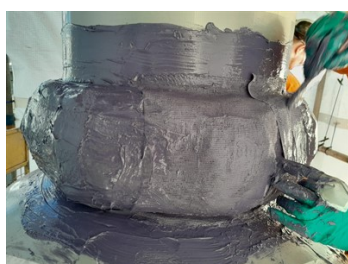
Wetting out of the Breather Membrane and vertical application of Reinforcement Sheets (Belzona 9341) using Belzona 7311.

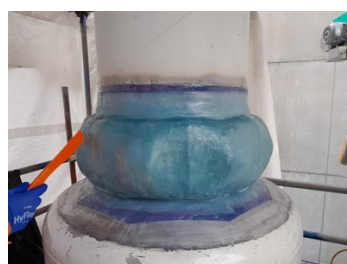
Post-application of 5x wraps of reinforcement sheet (Belzona 9371) and Belzona 1981 resin.

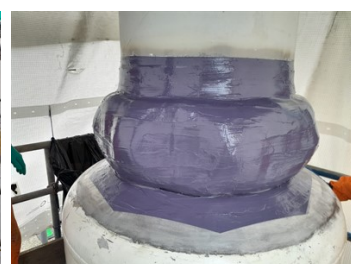
Final application after a further encapsulating layer of Belzona 7311.

Belzona conducted this application on a trial basis and had a remit to reduce the leak by at least a minimum of 80%. The application was undertaken within a 12-hour shift, and cost approximately £13,000, including all labour. The solution was classed as successful

after 3-months of service and is now being rolled out at other national substations.
