BELZONA REPAIRS AND SEALS IRON GUTTER

Application: RPA-Roof Problem Areas

Customer Location: Logistics Factory, Lancashire - UK

Traditional cast iron gutter 0.5 meters wide by 64 meters long

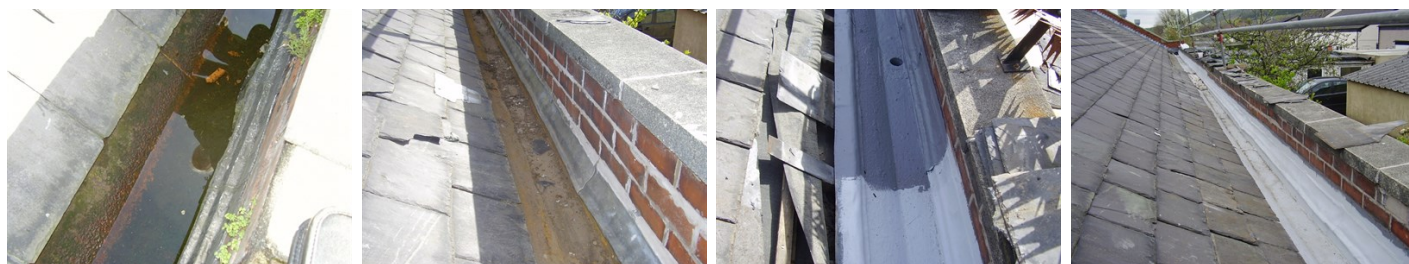
Photograph Descriptions

The cast iron had over time corroded and the joints deteriorated allowing water to enter the internal fabric of the building.

- * Blocked and corroded gutter ,
- * Gutter drained ready for preparation ,
- * Belzona fully reinforced Flexible Membrane system ,
- * Completed application ,

The application was carried out in accordance with Belzona Know-How System Leaflet RPA-6.
