# BELZONA REPAIRS AND SEALS IRON GUTTER

ID: 918

Customer Location: *Logistics Factory, Lancashire - UK*  
Application Date: *April 2007*

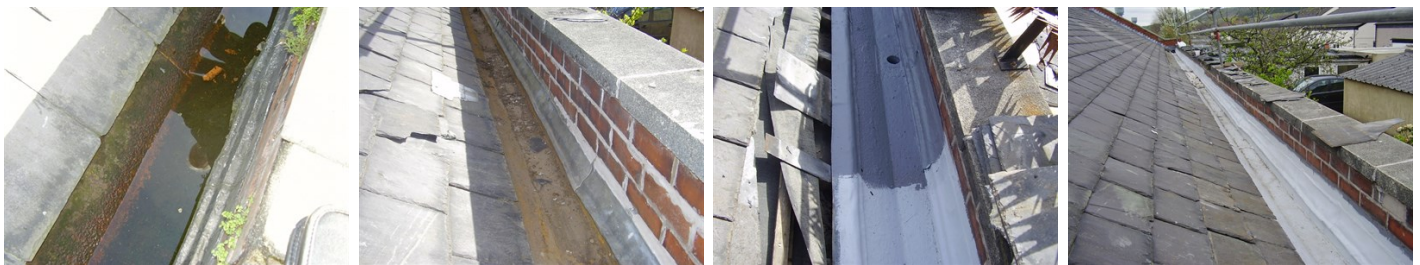
## Photograph Descriptions

*The cast iron had over time corroded and the joints deteriorated allowing water to enter the internal fabric of the building.*

- \* Blocked and corroded gutter ,
- \* Gutter drained ready for preparation ,
- \* Belzona fully reinforced Flexible Membrane system ,
- \* Completed application ,

Traditional cast iron gutter 0.5 meters wide by 64 meters long

The application was carried out in accordance with Belzona Know-How System Leaflet RPA-6.
