Belzona 4111 Repairs the Floor Drain

ID: 9181

Application: FPA-Floor Problem Areas

Customer Location: Tulsa Oklahoma

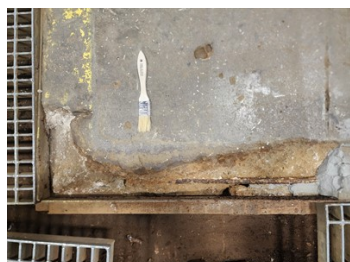
Damaged concrete at the edge of a floor drain trough.

Previous failed repair material removed.

The damaged area had been repaired with another material which was not bonded to the concrete, which resulted in an additional tripping hazard as it was now raised up. This is a water test area for large vessels and requires a smooth floor to roll carts over and sees a lot of foot traffic as well. An uneven floor in this area poses a huge danger to both employees and equipment.

The previous repair material was removed in large pieces with a screwdriver as it was not bonded to the concrete. A wire wheel on a drill was used to remove all of the loose concrete debris. A 4" hand grinder with a stone grinding wheel was used to remove the rust from the metal frame and exposed rebar, as well as to remove as much of the surface of the concrete as possible. The Belzona 4911 Conditioner was liberally applied ensuring that the full area of application was fully coated into the uneven surface. The Belzona 4111 was mixed following the Instructions For Use and packed in by hand to ensure there were no air pockets or voids, and then finished using a steel concrete trowel.

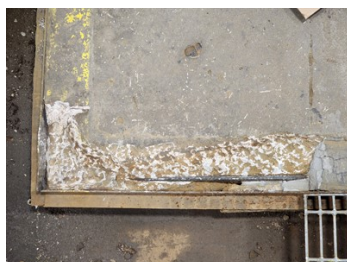
All loose material removed and the surface prepared with a hand grinder on both the concrete surfaces and metal surfaces.

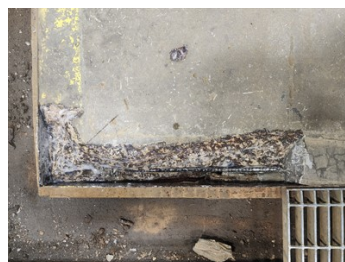
Belzona 4911 Conditioner applied liberally.

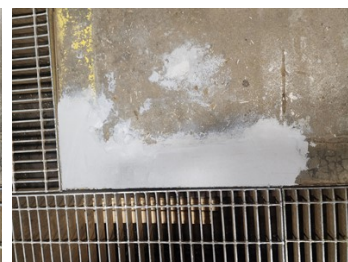
Belzona 4111 application completed.

This application used roughly one half of a 15 kg unit of Belzona 4111, and has eliminated the need for future repairs in this area for a couple hundred dollars of material. It was ready to go back into service within 24 hours, and the risk of employee injuries or equipment damage has been eliminated. The customer has already identified several other areas within their facility that will be repaired using Belzona 4111.
