Flange Face Reforming to Stop Leakage and Future Corrosion

ID: 9190

Industry: Commercial Facilities
 Application: VPF-Valves, Pipes and Fittings
 Substrate: Carbon steel
 Products: Belzona 1111 (Super Metal)

Customer Location: Dammam
 Application Date: October 2022

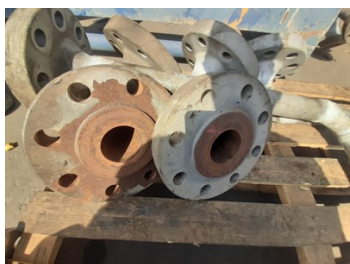
The flange faces were severely corroded and leaking.

Initial condition of flanges

Grit blasting with a surface profile of 75 microns and a cleanliness of Sa2.5. A former equal to the flange dimension was prepared. Belzona 9411 Release Agent was applied to the former and allowed to dry for some time. A layer of Belzona 1111 was applied to both the flange face and released former, then the paste grade material was built up across the flange face using a Belzona applicator cut to a V-shaped contour to form a high peak in the centre line. The flange and former were bolted together and left to cure according to the IFU. When the former was removed, the required serration pattern appeared on the flange face face, as requested by the customer.

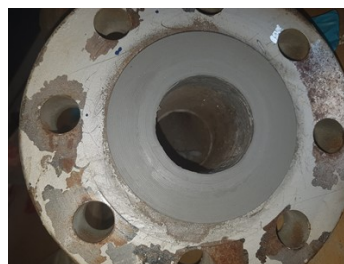
Flange faces rebuilt and restored using forming technique

Completed application
