Repair and Protection of Inter Stage Chiller Tubesheet

ID: 9191

Application: HEX-Heat Exchangers

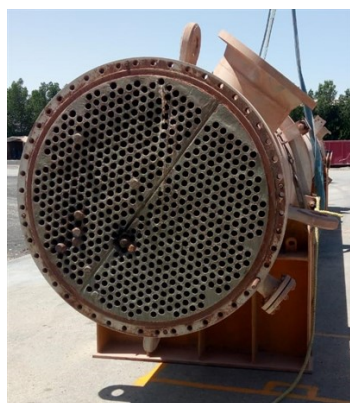
Tubesheet suffering from galvanic corrosion. Erosive damage at the division bar was observed; severe erosion due to the slurry medium.

Initial condition of the tubesheet

Hydro-jet cleaning was conducted first. Wooden plugs were inserted in all tubes to protect against high speed abrasives. A surface profile of 75 microns and a cleanliness of Sa2.5 were achieved. Rebuilt using Belzona 1311 paste grade and protected the tubesheet using Belzona 1392 coating grade. The repair and coating work was carried out in accordance with the Belzona System Leaflets HEX-1 and HEX-3.

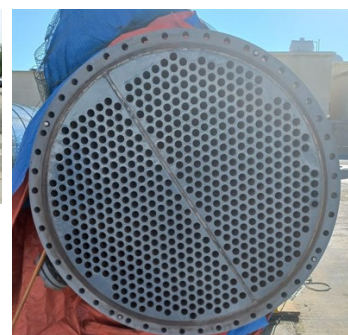
Completed application
