Protection of Pump Impeller from Seawater Service

ID: 9192

Industry: Oil & Gas
Application: CEP-Centrifugal Pumps
Substrate: Carbon steel
Products: Belzona 1341 (Supermetalglide)

Customer Location: Dhahran
Application Date: July 2023

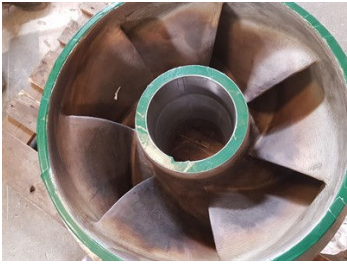
The impeller was exposed to corrosion due to unfiltered seawater as the pump medium. The customer needed a coating that could prevent corrosion and increase pump efficiency.

Before application

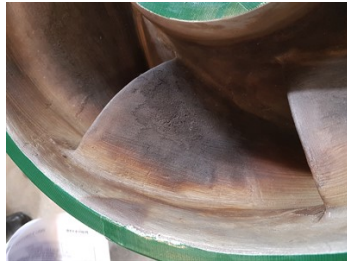
Close up of impeller vanes

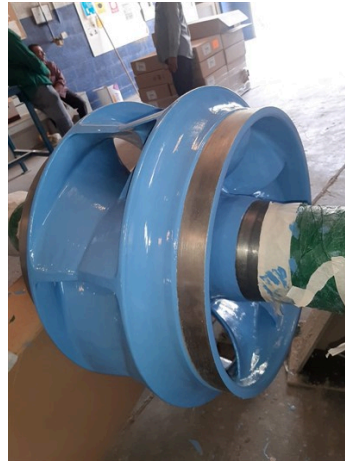
Fully coated impeller for protection

Grit blasting with a surface profile of 75 microns and a cleanliness of Sa2.5. Application was carried out in accordance with Belzona Know-How System Leaflet CEP-3 with two coats of Belzona 1341 according to the IFU.

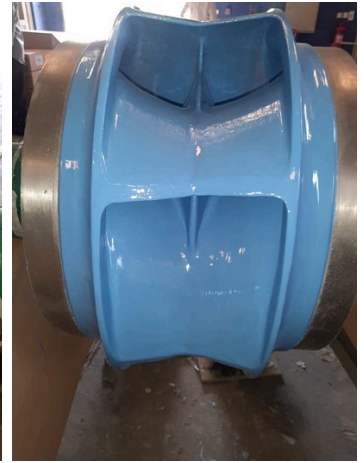
Another angle for completed application
