# Protection of Pump Impeller from Seawater Service

Industry: Oil & Gas  
Application: CEP-Centrifugal Pumps  
Substrate: Carbon steel  
Products: Belzona 1341 (Supermetalgilde)

Customer Location: Dhahran  
Application Date: July 2023

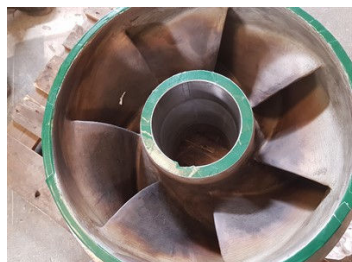
The impeller was exposed to corrosion due to unfiltered seawater as the pump medium. The customer needed a coating that could prevent corrosion and increase pump efficiency.

Before application

Grit blasting with a surface profile of 75 microns and a cleanliness of Sa2.5. Application was carried out in accordance with Belzona Know-How System Leaflet CEP-3 with two coats of Belzona 1341 according to the IFU.

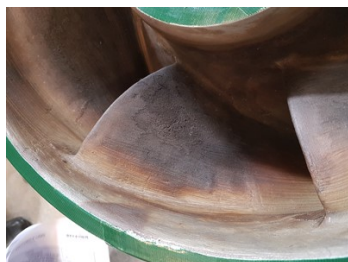
Close up of impeller vanes

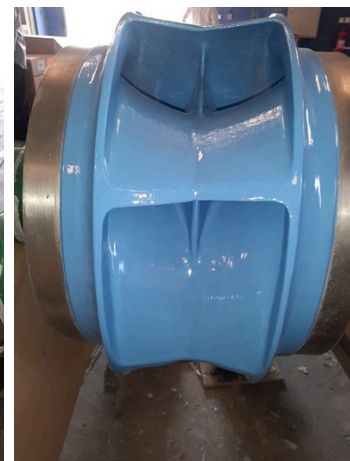
Another angle for completed application
