# Belzona Repairs and Protects a Split Casing Pump

ID: 9193

Application: CEP-Centrifugal Pumps

Products: Belzona 1111 (Super Metal), Belzona 1341 (Supermetalglide)

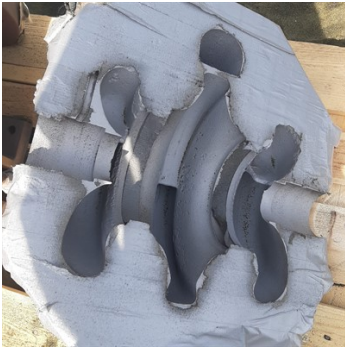
The customer noticed small cavities in the casing due to pitting corrosion during inspection and were concerned about the life of the equipment as this could lead to failure.

Grit blasted casing

Application was carried out in accordance with Belzona Know-How System Leaflets CEP-3, CEP-5 and CEP-10. Belzona 1111 was applied to the the pitted area and the casing was further protected with two coats of Belzona 1341.

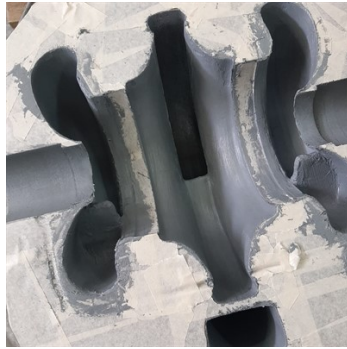
Pit filling and rebuilding application prior to coating

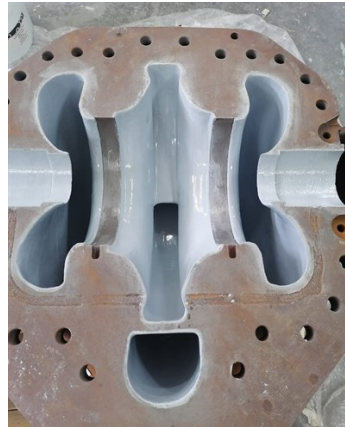
Coated and protected casing interior
