Belzona Repairs and Protects a Split Casing Pump

Industry: Oil & Gas
Application: CEP-Centrifugal Pumps
Substrate: Carbon steel
Products: Belzona 1111 (Super Metal), Belzona 1341 (Supermetalglide)

Customer Location: Al Khaffi
Application Date: May 2022

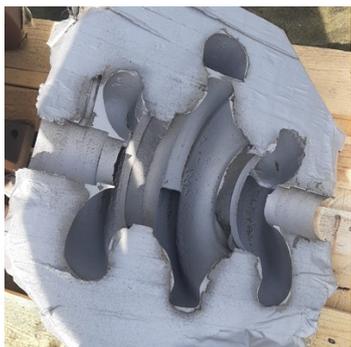
Grit blasted casing

Application was carried out in accordance with Belzona Know-How System Leaflets CEP-3, CEP-5 and CEP-10. Belzona 1111 was applied to the pitted area and the casing was further protected with two coats of Belzona 1341.

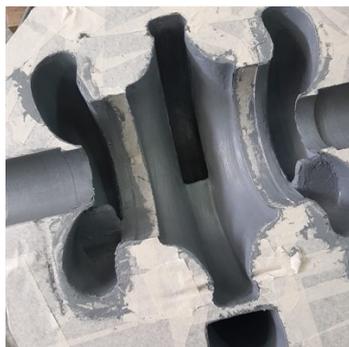
Pit filling and rebuilding application prior to coating

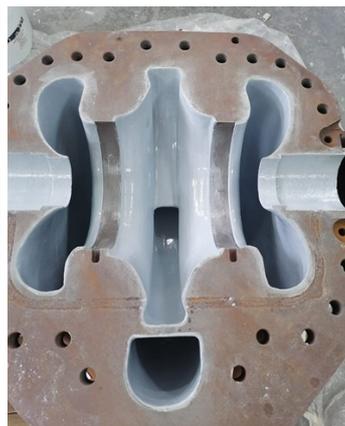
Coated and protected casing interior
