Successful Trial Application for Pump Cone and Impeller in Hydropower Plant

ID: 9200

Industry:	Power	Customer Location:	Frontino, Antioquia, Colombia
Application:	CEP-Centrifugal Pumps	Application Date:	October 2022
Substrate:	Carbon steel		
Products:	Belzona 1111 (Super Metal), Belzona 1341N (Supermetalglide), Belzona 2141 (ACR-Fluid Elastomer), Belzona 2911 (Elastomer QD Conditioner)

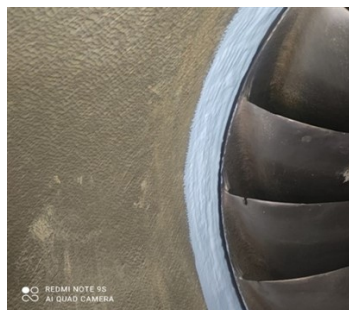
Belzona 1111 used to repair and Belzona 1341N used to protect the perimeter area of the cone.

For cone application:

- Brushes to be used were cut by half for an effective application.
- Belzona 1111 was mixed by volume - three parts of Base to one part of Solidifier until reaching an homogeneous color.
- Area was repaired with Belzona 1111 and left to cure for two hours.
- Belzona 1341N was mixed by volume - three parts of Base to two parts of Solidifier until reaching an homogeneous color.
- First coat was applied at a thickness of 10 mils (250 microns) and left to cure according to the Instructions for Use.
- Once past cure time, a second coat of Belzona 1341N was applied at a thickness of 10 mils (250 microns) and the application was left to cure.

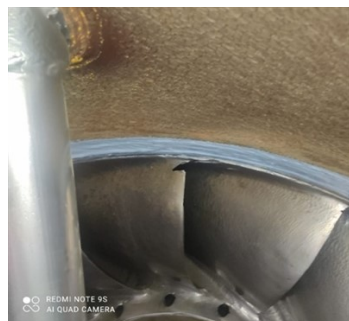
Different angle of Belzona 1111 being used to repair and Belzona 1341N being used to protect the perimeter area of the cone.

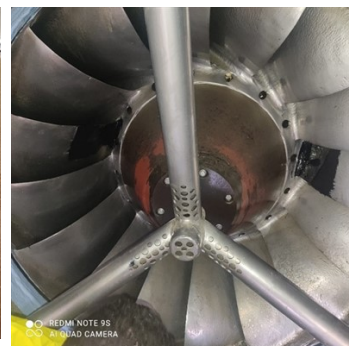
Belzona 2141 used to protect the impeller from cavitation.

For impeller application:

- Brushes to be used were cut by half for an effective application.
- Belzona 2911 was used to condition the surface. Conditioner was left to dry for forty five minutes.
- Belzona 2141 was mixed completely for two minutes until reaching an homogeneous color.
- One coat of Belzona 2141 was applied at a thickness of 32 mils (800 microns) to the repair areas and left to cure according to the Instructions for Use.
