Successful Trial Application for Pump Cone and Impeller in Hydropower Plant

ID: 9200

Customer Location: Frontino, Antioquia, Colombia
Application Date: October 2022

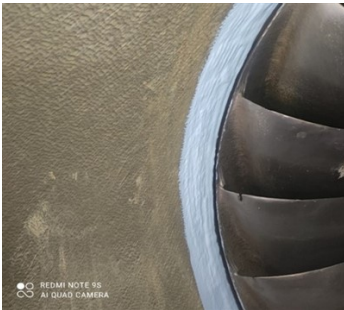
Belzona 1111 used to repair and Belzona 1341N used to protect the perimeter area of the cone.

- Brushes to be used were cut by half for an effective application.
- Belzona 1111 was mixed by volume - three parts of Base to one part of Solidifier until reaching an homogeneous color.
- Area was repaired with Belzona 1111 and left to cure for two hours.
- Belzona 1341N was mixed by volume - three parts of Base to two parts of Solidifier until reaching an homogeneous color.
- First coat was applied at a thickness of 10 mils (250 microns) and left to cure according to the Instructions for Use.
- Once past cure time, a second coat of Belzona 1341N was applied at a thickness of 10 mils (250 microns) and the application was left to cure.

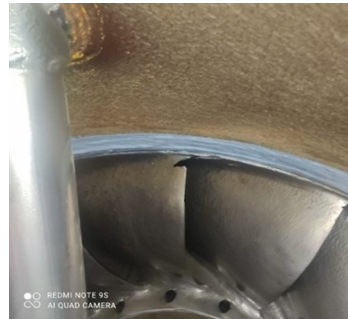
Different angle of Belzona 1111 being used to repair and Belzona 1341N being used to protect the perimeter area of the cone.

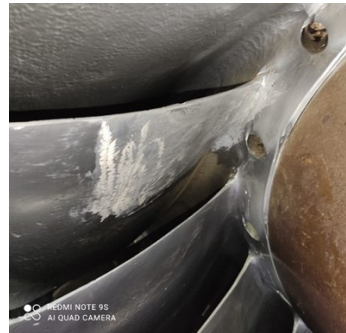
Belzona 2911 used to condition the repair area of the impeller.

- Brushes to be used were cut by half for an effective application.
- Belzona 2911 was used to condition the surface. Conditioner was left to dry for forty five minutes.
- Belzona 2141 was mixed completely for two minutes until reaching an homogeneous color.
- One coat of Belzona 2141 was applied at a thickness of 32 mils (800 microns) to the repair areas and left to cure according to the Instructions for Use.

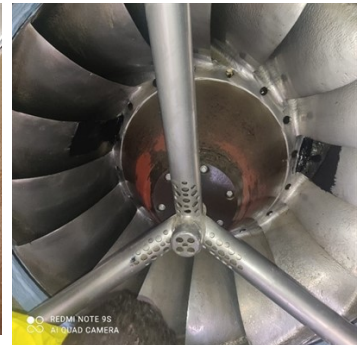
Belzona 2141 used to protect the impeller from cavitation.
