# Dryer Box - Belzona 1813

ID: 9210

Industry: *Chemical & Petrochemical*  
Application: *SHM-Solids Handling Machinery*

Substrate: *Carbon steel*  
Products: *Belzona 1813*

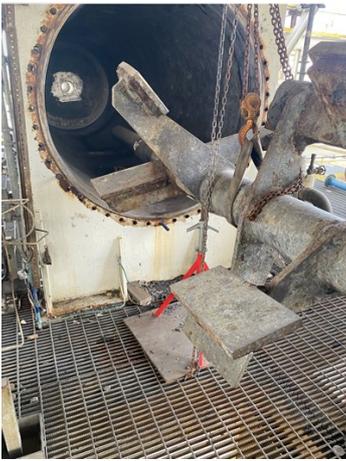
Dryer Box unit prior to abrasive blasting.

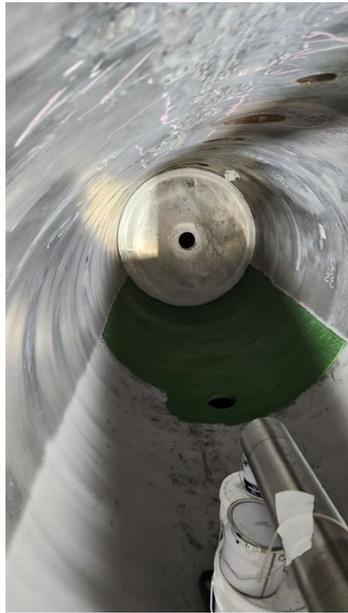
Grit blasted steel and progress of the Belzona 1813 installation.

The unit was abarasive blasted to SSPC-SP10 with a minimum 3 mil dense and angular profile. The Belzona 1813 was applied with plastic applicators and trowels.

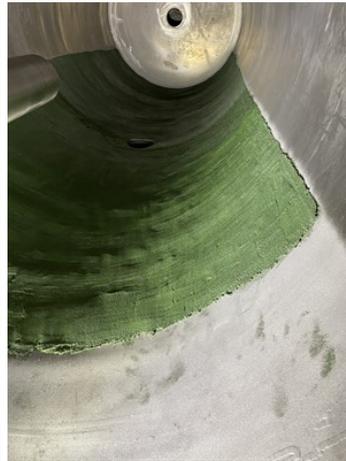
Application to the belly of the Dryer Box unit.

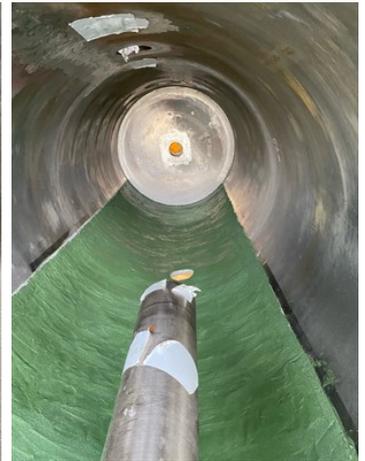
Finished application of the Belzona 1813. This was allowed to fully cure prior to placing in service.
