Belzona Repairs Conveyor Belt

ID: 9213

Industry: *Mining & Quarrying*
Application: *SHM-Solids Handling Machinery*

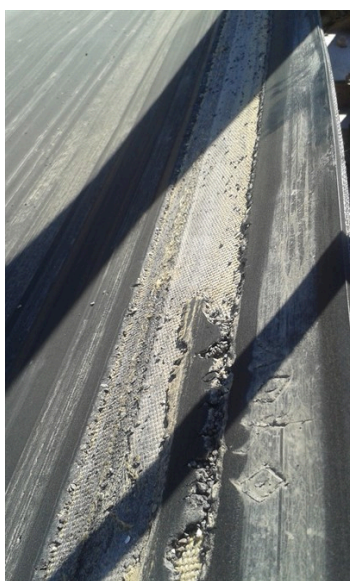
A 10 meter section of the top layer rubber on a belt wore out.

Condition of belt

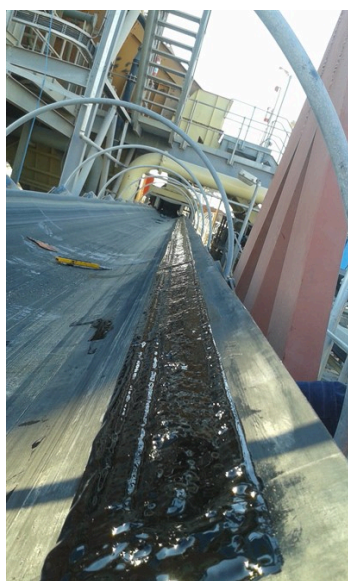
After application

After abrading the belt, it was cleaned and degreased with Belzona 9111. A thin layer of Belzona 2911 Conditioner was applied to the damaged section.

Once the conditioner was touch dry, Belzona 2131 was applied and allowed to fully cure.
