# Belzona Repairs Conveyor Belt

ID: 9213

Industry: *Mining & Quarrying*  
Application: *SHM-Solids Handling Machinery*

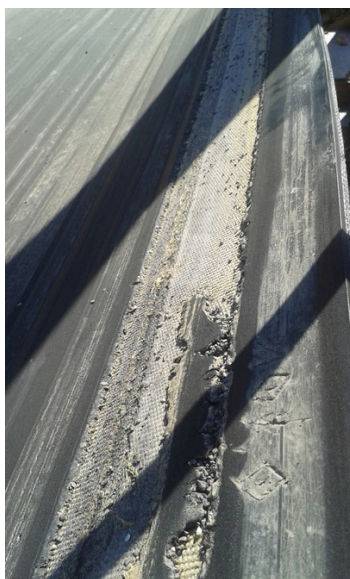
*A 10 meter section of the top layer rubber on a belt wore out.*

Condition of belt

After abrading the belt, it was cleaned and degreased with Belzona 9111. A thin layer of Belzona 2911 Conditioner was applied to the damaged section.

Once the conditioner was touch dry, Belzona 2131 was applied and allowed to fully cure.

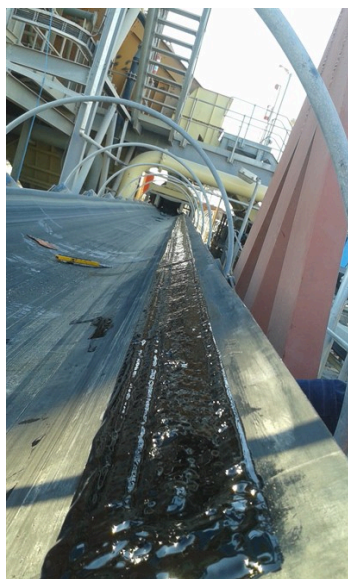
After application
