# SILL REPAIRS WITH BELZONA

Application: WPA-Wall Problem Areas

Customer Location: Local Council-UK

Application Date: October 2007

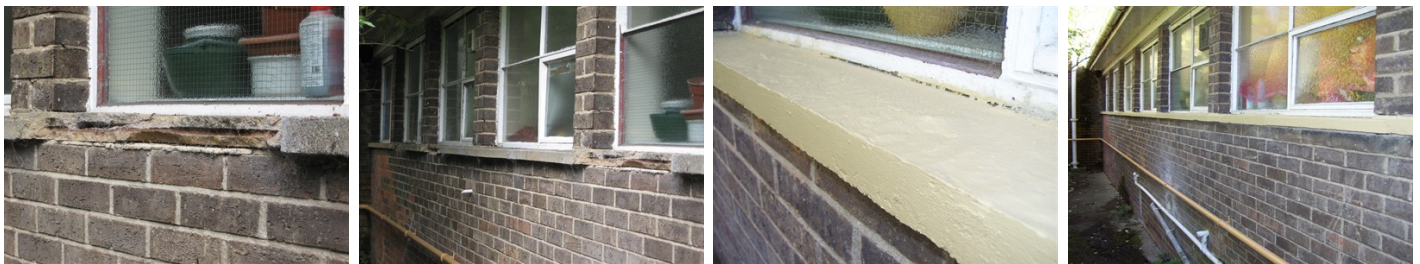
## Photograph Descriptions

A childcare centre were having safety issues with pieces of concrete falling from window sills due to the spalling concrete.

- \* Damaged sills before the repair ,
- \* Exposed and corroded reinforcement bars ,
- \* Rebuilt using Belzona® 4141 & coated with Belzona® 5151 ,
- \* Completed repairs ,

Damage to concrete window sills due to corrosion of reinforcement bars.

Application carried out in accordance with the Belzona Know-How System Leaflets WPA-1 and WPA-4.

This customer chose to use Belzona to reduce cost and the disruption, the alternative was to remove the windows, re-cast the sills and then replace once they had cured, this would have resulted in the Childcare centre being closed for over 4 weeks.
