SILL REPAIRS WITH BELZONA

ID: 923

Application: WPA-Wall Problem Areas

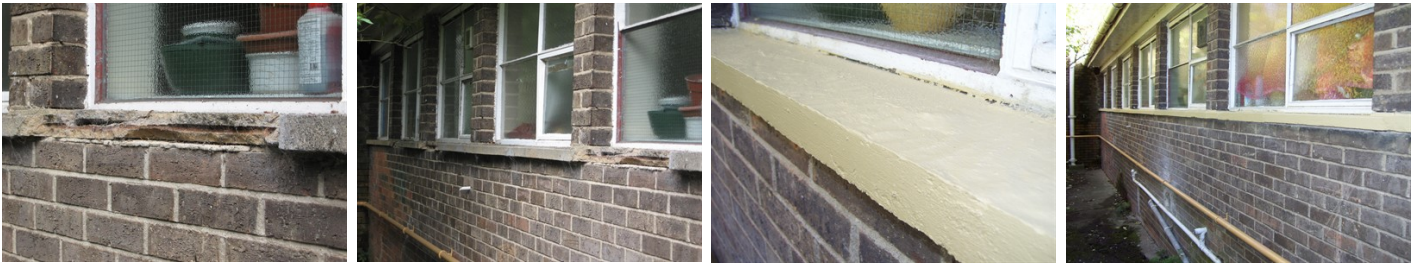
A childcare centre were having safety issues with pieces of concrete falling from window sills due to the spalling concrete.

- * Damaged sills before the repair ,
- * Exposed and corroded reinforcement bars ,
- * Rebuilt using Belzona® 4141 & coated with Belzona® 5151 ,
- * Completed repairs ,

Damage to concrete window sills due to corrosion of reinforcement bars.

Application carried out in accordance with the Belzona Know-How System Leaflets WPA-1 and WPA-4.

This customer chose to use Belzona to reduce cost and the disruption, the alternative was to remove the windows, re-cast the sills and then replace once they had cured, this would have resulted in the Childcare centre being closed for over 4 weeks.
