# Common problem within Pharmaceutical industry

ID: 9236

**Industry:** Pharmaceutical  
**Application:** TCC-Tanks and Chemical Containment Areas  
**Substrate:** Concrete  
**Products:** Belzona 4361, Belzona 4911 (Magma TX Conditioner)

**Customer Location:** Dublin, Ireland  
**Application Date:** January 2023

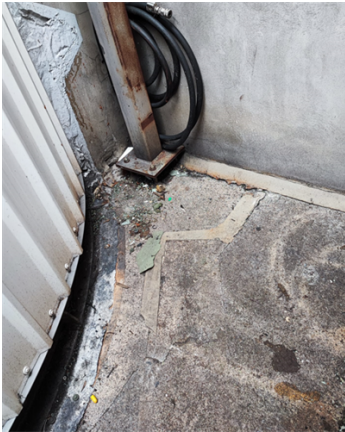
Several deep cracks in concrete around bund area.

Clears signs of chemical damage on bund floor

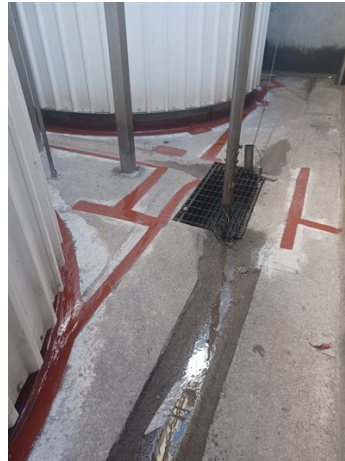
Failure of tank base seals leading to moisture ingress

Repairs with 4131 and sealing of cracks with 4361

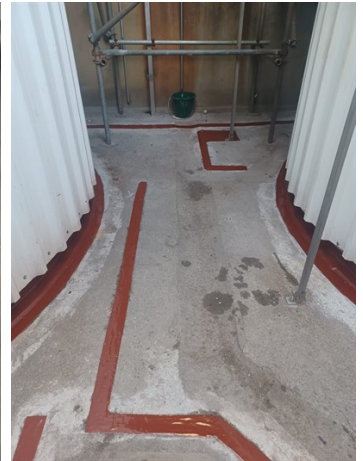
More repair areas

- Area was cleaned of debris and an abrasive wheel was used to provide a rough surface for the purpose of adhesion.
- Belzona 4911 applied as a conditioner and allowed to dry.
- Initial coat of Belzona 4361 applied and allowed to become touch dry.
- Second coat was applied after 4 hours.
