# Belzona Florida Repairs water Discharge Flange

Industry: Power  
Application: VPF-Valves, Pipes and Fittings  
Substrate: Concrete  
Products: Belzona 1111 (Super Metal), Belzona 1321 (Ceramic S-Metal)

Customer Location: Fort Lauderdale, Florida  
Application Date: December 2023

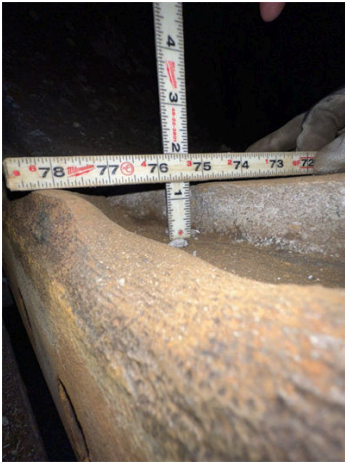
The customer had a non-Belzona coating previously applied that failed, causing corrosion scaling on the interior edge of the flange.

Showcasing and measuring the damage caused by the corrosion.

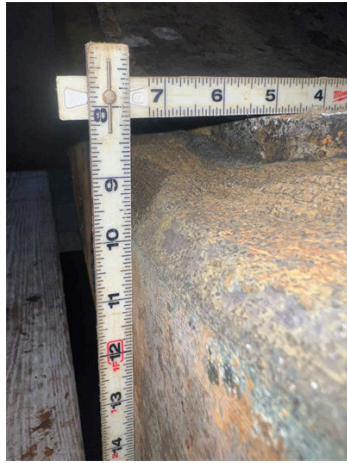
Showcasing and measuring the damage caused by the corrosion.
