# Rebuilding concrete columns in a colling tower.

ID: 9241

Application: WPA-Wall Problem Areas

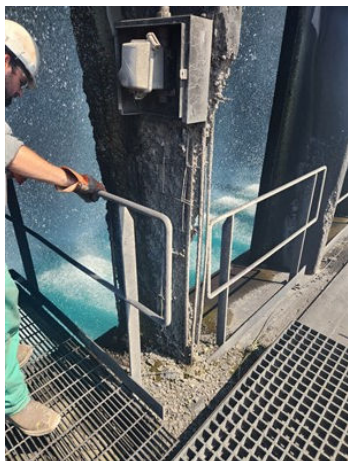
The customer faced deteriorations of concrete columns with exposed rebars in their cooling tower.

Deterioration of the columns

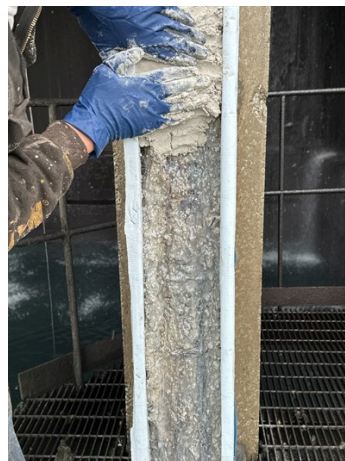
Application of Belzona 4141 for repair

Specific techniques, such as floats and a wood mold, were employed for the best finish. After curing, the product was sanded for an even better result.
