# Linde Intercooler Repair

Application: HEX-Heat Exchangers

Substrate: Carbon steel

Products: Belzona 1111 (Super Metal), Belzona 1321 (Ceramic S-Metal)

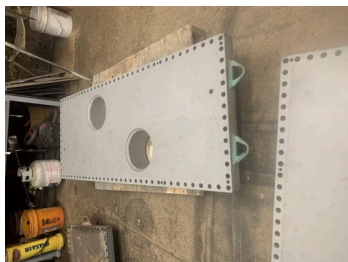
Intercooler tube sheet and end covers had corrosion due to b-metallic corrosion.

Before application

The application was carried out in accordance with Belzona Know-How System Leaflet HEX-1 for repairing eroded-corroded tube sheets. The surface was prepared by grit blasting and the surface was washed with Belzona 9111. The tubes were plugged with rubber stoppers and Belzona 1111. The second coat of Belzona 1321 was applied in accordance with Belzona Instructions for Use.

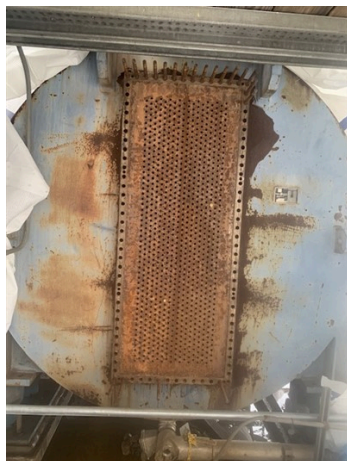
Overview of application area

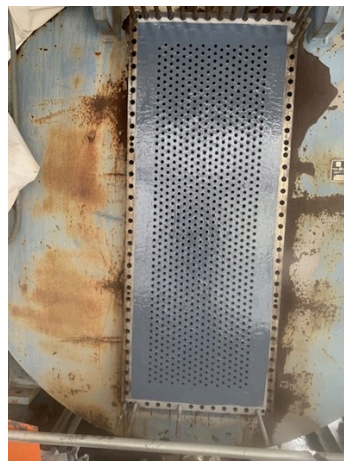
Final application
