# Belzona repairs 600-metre long Steel plant conveyor belt

Application: SHM-Solids Handling Machinery

Application Date: February 2015

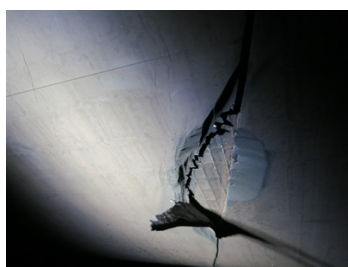
Conveyor Belt to repair.

Damage to Belt

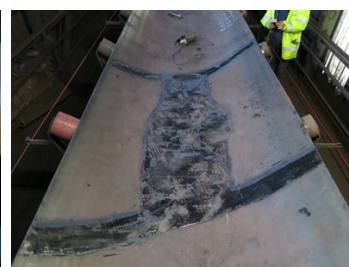
Completed Application

The client tested all the rapid repair systems available on the market. Belzona 2111 and Belzona 2311 performed very well. All other systems had either too little adhesion or less wear resistance. The production downtime for repairs in the summertime was only 8 to 10 hours. We also had repairs in wintertime at minus 15°C. On these occasions, we had to build housing and heat the repair area with propane gas burners to get heat and also enough humidity to dry the primer 2911.

The application was carried out in accordance with Belzona system leaflet SHM-1 • FOR REPAIRING RIPPED, TORN AND WORN CONVEYOR BELTS
