SANDSTONE MULLION REPAIRS WITH BELZONA

ID: 925

Application: WPA-Wall Problem Areas

Substrate: Red Sandstone

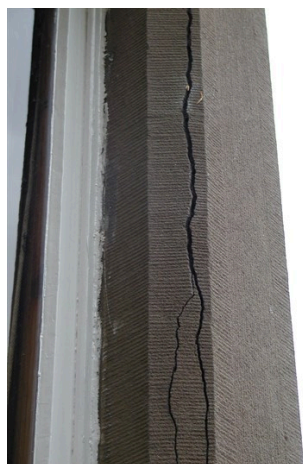
The cracks were getting worse due to frost damage in the winter months and previous attempts at concrete repairs had failed at the bond lines.

- * The problem. Note the grooving of the sandstone. ,
- * Belzona® 4141 being applied as a skim coat. ,
- * Finished application. ,
- * Inspected December 2007. ,

Householder had a problem of cracks in the sandstone Mullions of his bay windows.

Application was carried out in accordance with Belzona Know-How System Leaflet WPA-4. The cracks were opened out and filled prior to the whole mullion being skimmed with Belzona® 4141 tinted to match the colour. The original grooving on the stone was replicated in the Belzona® 4141.
