Belzona 5811 & 3121 Seals Stair Landing from Future Leaks

Application: FPA-Floor Problem Areas

Customer Location: Birmingham, AL

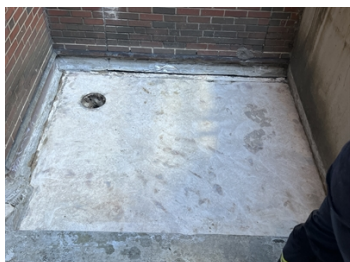
Old Coating was removed and floor was taken to bare concrete by a diamond grinder.

After removing the thick mat-like coating that had bubbled and failed, we prepared the concrete floor and 8" up the wall with a diamond grinder to achieve desired substrate. We then proceeded with building a 2" cove out of Belzona 4111 to the seam where the wall meets the floor on all sides. Next, we applied 1 coat of Belzona 5811 to the floor and up the walls 8". After curing we painted an 8" strip bridging the floor to the wall out of Belzona 3121 engrained into reinforcement cloth finishing with a second coat of Belzona 3121. 3 weeks later and heavy rains, they are not experiencing any more leaks.

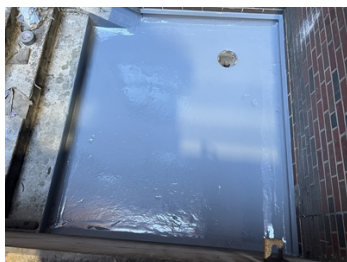
Belzona 5811 as our base coat to the "basin"

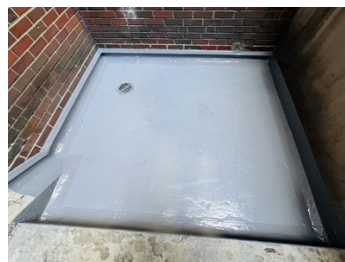
Belzona 3121 with Reinforcement cloth to the seams

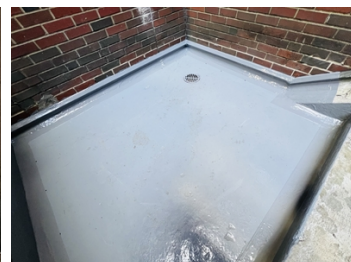
Final product
