# Belzona 5811 & 3121 Seals Stair Landing from Future Leaks

ID: 9257

Industry: Buildings & Structures  
Application: FPA-Floor Problem Areas  
Substrate: Concrete  
Products: Belzona 3121 (MR7), Belzona 4111 (Magma-Quartz), Belzona 5811 (Immersion Grade)

Customer Location: Birmingham, AL  
Application Date: January 2024

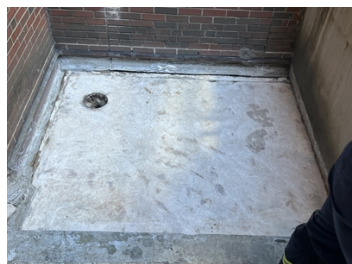
Old Coating was removed and floor was taken to bare concrete by a diamond grinder.

After removing the thick mat-like coating that had bubbled and failed, we prepared the concrete floor and 8" up the wall with a diamond grinder to achieve desired substrate. We then proceeded with building a 2" cove out of Belzona 4111 to the seam where the wall meets the floor on all sides. Next, we applied 1 coat of Belzona 5811 to the floor and up the walls 8". After curing we painted an 8" strip bridging the floor to the wall out of Belzona 3121 engrained into reinforcement cloth finishing with a second coat of Belzona 3121. 3 weeks later and heavy rains, they are not experiencing any more leaks.

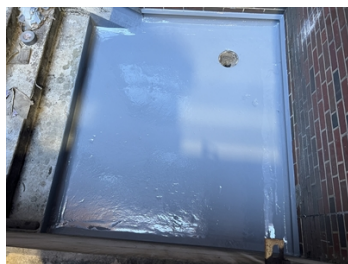
Belzona 5811 as our base coat to the "basin"

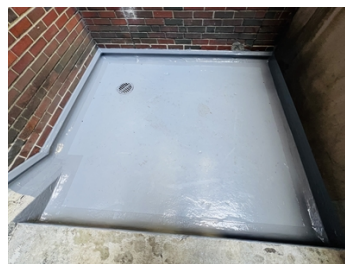
Belzona 3121 with Reinforcement cloth to the seams

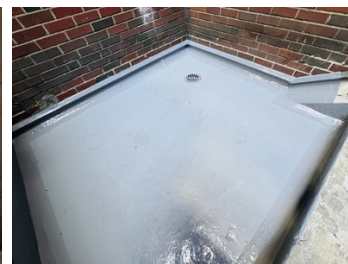
Final product
