# BELZONA SUPERWRAP II DESIGN SOLUTION

ID: 9259

**Industry:** Oil & Gas  
**Application:** VPF-Valves, Pipes and Fittings  
**Substrate:** Carbon steel  
**Products:** Belzona 1212, Belzona 1983 (SuperWrap II), Belzona SuperWrap II, Belzona 9111 (Cleaner Degreaser)

**Customer Location:** Fredericia, Denmark  
**Application Date:** August 2023

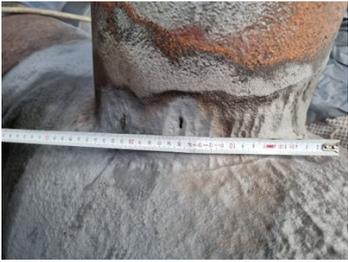
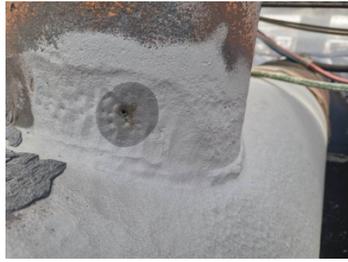
The refinery was experiencing corrosion on their pipe at a port terminal, which required either a large maintenance shutdown, or an alternative solution had to be found.

Damaged pipe

First, the pipe was gritblasted and cleaned with Belzona 9111. Belzona 1212 was used to rebuild the pipe to its original size. Belzona 1983 was chosen as the resin for the project, superwrap was carried out according to specifications, by certified SuperWrap II installer and supervisor.

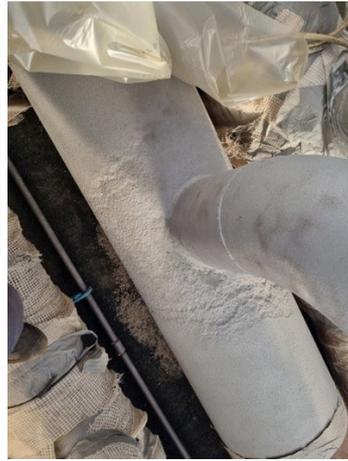
Blasted pipe, ready for superwrap

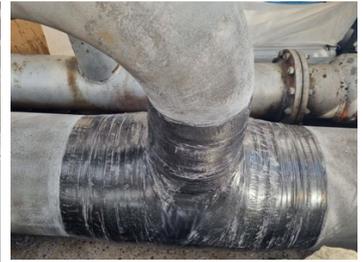
Superwrap installed

Changing a pipe with a branch is a costly affair and requires a long shutdown. Belzona was chosen for the quick solution, and the solution is compliant with ASME PPC 2, which gave the customer the necessary security for the repair. The repair was designed so that all requirements from the customer are met.
