BELZONA PROTECTION FOR GEARBOX INTERNAL

ID: 926

Customer Location: Power Station, UK
Application Date: February 2007

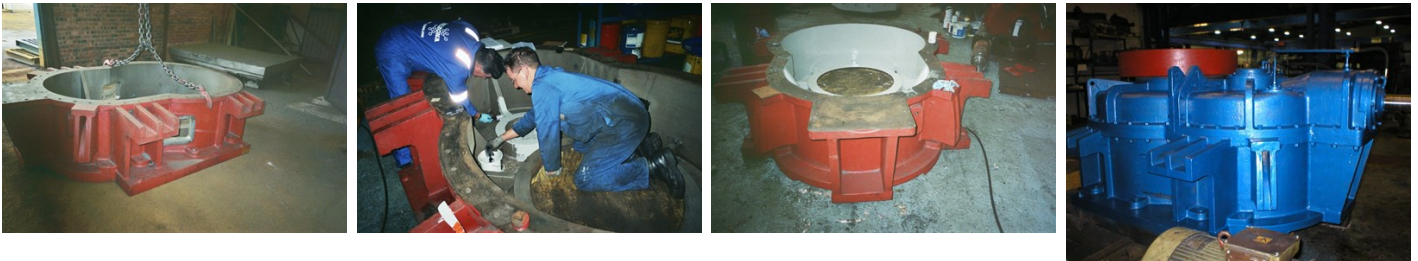
Photograph Descriptions

Internal protection required by client to ensure long service life. Previous coatings had failed prematurely causing bearing failure and oil seal damage.

* Bare gearbox in workshop , * Application of Belzona® 5891 underway , * Application complete , * Assembled gearbox ready for service ,

The application was carried out in accordance with the Belzona Know-How System Leaflet TCC-5. Special attention was paid to surface preparation, particularly with regard to removing all impregnated oil and achieving correct grit blast profile.
