REGULAR BELZONA SUPERWRAP II ON LOW SPECIFICATION PIPING SYSTEMS

Industry: Oil & Gas
Application: VPF-Valves, Pipes and Fittings
Substrate: Carbon steel
Products: Belzona 1111 (Super Metal), Belzona 1161 (Super UW-Metal), Belzona 1981 (SuperWrap II)

Customer Location: North Sea Norway
Application Date: December 2022

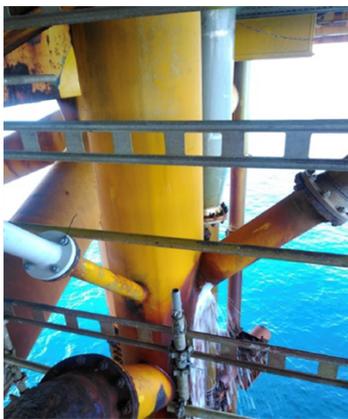
Due to years of neglected priority of maintenance, the client was experiencing severe corrosion challenges on their low-specification piping systems. This meant they were now facing a costly and time-consuming replacement of large sections of important equipment.

Severe corrosion on 24" caisson.

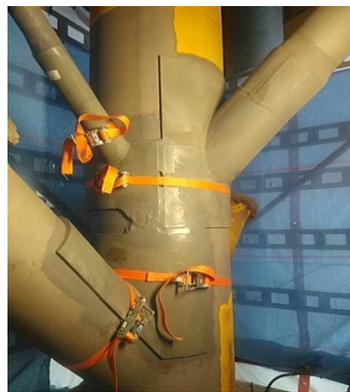
Bonding custom made reinforcement plates.

Custom made 10mm doublerplates was bonded over severely corroded areas to add structural strength and extended wallthickness to the piping system.

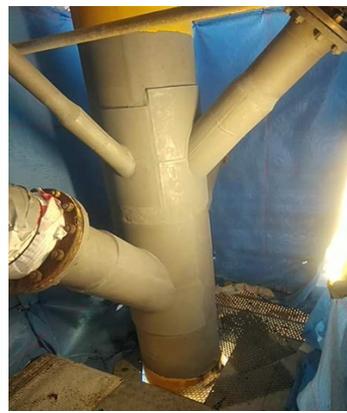
Preparing for SuperWrap II Application

After full cure of the bonding application the surface was grit blasted a second time and prepared for a designed Belzona SuperWrap II application.

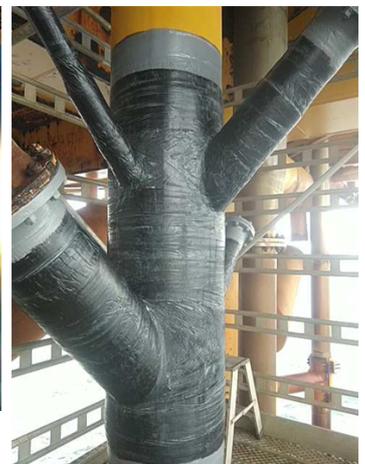
SuperWrap II Application completed.

Belzona 1981 SuperWrap II resin and Belzona 9381 SuperWrap II reinforcement was used to install a 4 spiral / 8 layer - Designed SuperWrap II.
