BELZONA REFURBISHES DN 500 FISHFARM SEAWATER PUMPS

Industry: Marine
Application: CEP-Centrifugal Pumps
Substrate: Cast Iron
Products: Belzona 1311 (Ceramic R-Metal), Belzona 1321 (Ceramic S-Metal)

Customer Location: Norway
Application Date: June 2022

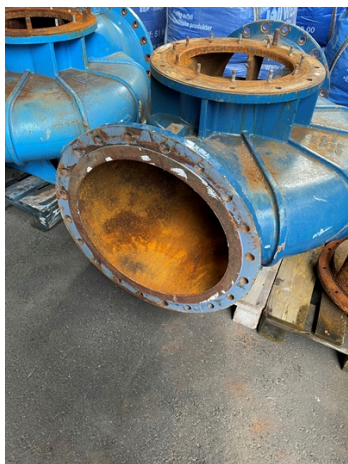
Seawater pump housings was suffering from internal corrosion and local erosion after a short period in service. In order to prevent breakdown of the pumps, the customer urgently decided to rebuild and protect the internal surfaces.

Corroded pump housings

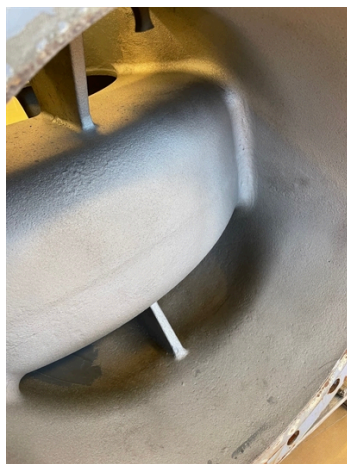
Grit blasted details

1. The pump housings was internally grit blasted to SA-2,5 with a minimum surface profile of 75 microns according to ISO 1805-1
2. Corroded and worn areas was rebuilt and restored using Belzona 1311 Ceramic R-metal
3. A second grit blasting of both internals and externals to SA-2,5 with a minimum surface profile of 75 microns according to ISO 1805-1 was carried out.
4. Internal surfaces was coated with 2 layers a 375micron of Belzona 1321 Ceramic S-metal.

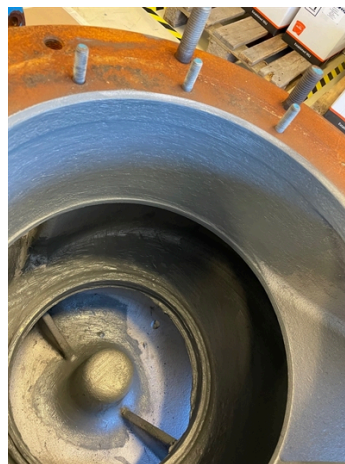
Rebuilding in progress

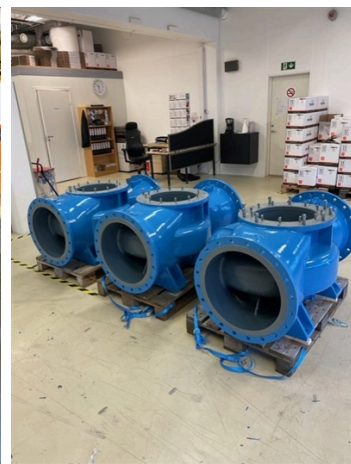
Coating application completed.
