# Belzona 7311 cold plate bonding on trunnion

ID: 9266

Industry: *Chemical & Petrochemical*  
Application: *VPF-Valves, Pipes and Fittings*  
Substrate: *Carbon steel*  
Products: *Belzona 7311*

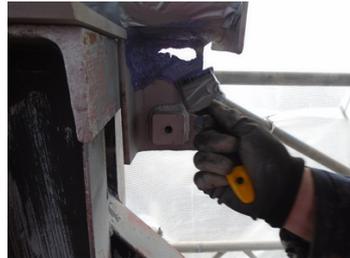
*Corrosion had occurred on a trunnion section leading to significant metal loss*

Corroded section covered in wax oil

Surface preparation & wetting out with Belzona 7311

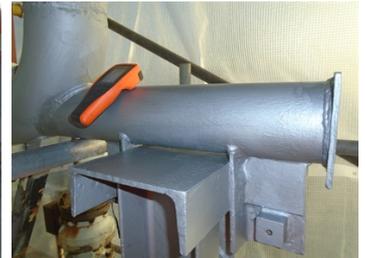
Doubler plates installed & clamped in place

Completed repair overcoated

The area was grit blasted to SA2.5 & 75 microns. The metal surface was then wetted out. Doubler plates were then bonded either side of the defect & clamped to avoid slumping. Once cured the full area was painted.
