Belzona 7311 cold plate bonding on trunnion

ID: 9266

Industry: Chemical & Petrochemical
Application: VPF-Valves, Pipes and Fittings
Substrate: Carbon steel
Products: Belzona 7311

Customer Location: United Kingdom
Application Date: December 2023

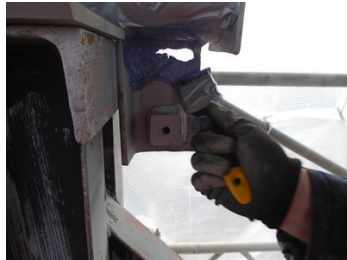
Corrosion had occurred on a trunnion section leading to significant metal loss

Corroded section covered in wax oil

The area was grit blasted to SA2.5 & 75 microns. The metal surface was then wetted out. Doubler plates were then bonded either side of the defect & clamped to avoid slumping. Once cured the full area was painted.

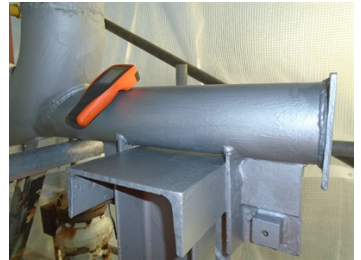
Surface preparation & wetting out with Belzona 7311

Doubler plates installed & clamped in place
