Belzona 7311 cold plate bonding on trunnion

ID: 9266

Industry: *Chemical & Petrochemical*
Application: *VPF-Valves, Pipes and Fittings*
Substrate: *Carbon steel*
Products: *Belzona 7311*

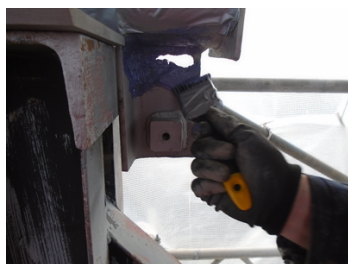
Corrosion had occurred on a trunnion section leading to significant metal loss

Corroded section covered in wax oil

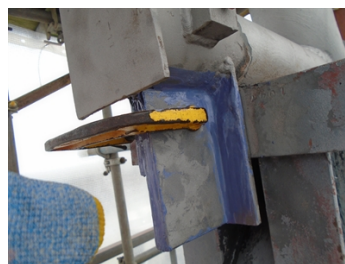
Surface preparation & wetting out with Belzona 7311

The area was grit blasted to SA2.5 & 75 microns. The metal surface was then wetted out. Doubler plates were then bonded either side of the defect & clamped to avoid slumping. Once cured the full area was painted.
