# Belzona chiller repair that was completed in only one day!

ID: 9268

Application: HEX-Heat Exchangers

Customer Location: Dallas, Texas

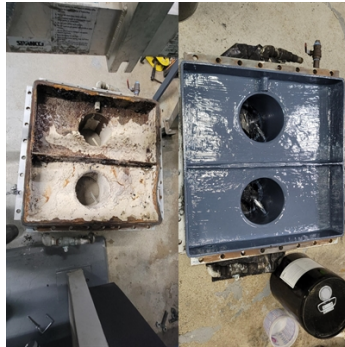
*This chiller has been running uncoated since new for years in a building in downtown Dallas. Bad water treatment has left the chiller with a lot of damage and build up.*

Before and after Belzona application

This chiller had no efficiency left. It was decided to do a full Belzona repair system on it. First the chiller was cleaned and then grit blasted. Belzona 1121 was used to repair holes and metal loss in the chiller face. After that Belzona 1321 two good system was applied to chiller. Belzona was left to dry and it was finished off by taking out the corks out of the tubes and finishing up the repair.

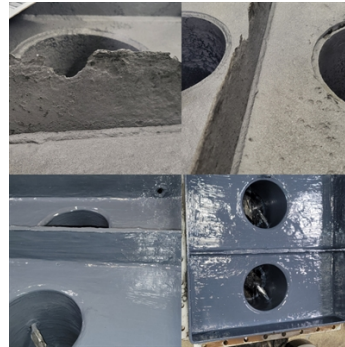
Before and after Belzona application

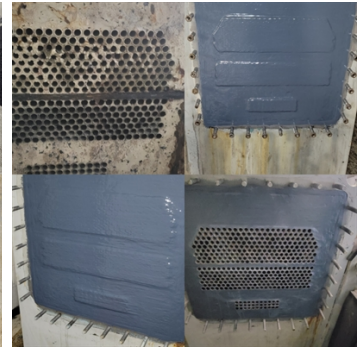
Before and after Belzona application
