# Belzona chiller repair that was completed in only one day!

Application: HEX-Heat Exchangers

Products: Belzona 1121 (Super XL-Metal), Belzona 1321 (Ceramic S-Metal)

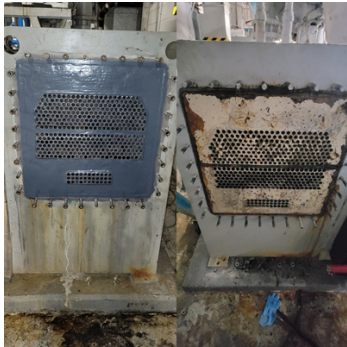
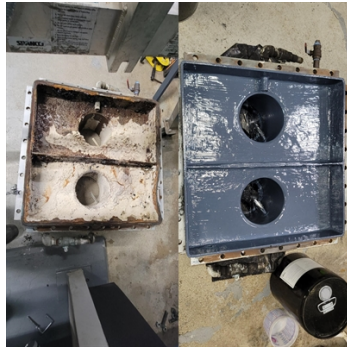
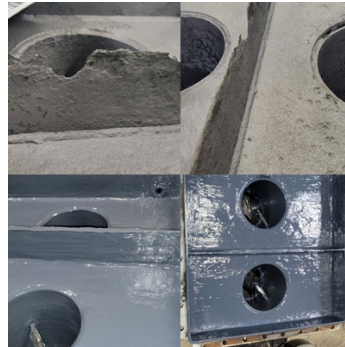
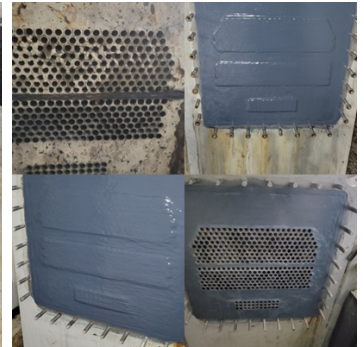
*This chiller has been running uncoated since new for years in a building in downtown Dallas. Bad water treatment has left the chiller with a lot of damage and build up.*

Before and after Belzona application

This chiller had no efficiency left. It was decided to do a full Belzona repair system on it. First the chiller was cleaned and then grit blasted. Belzona 1121 was used to repair holes and metal loss in the chiller face. After that Belzona 1321 two good system was applied to chiller. Belzona was left to dry and it was finished off by taking out the corks out of the tubes and finishing up the repair.
