BELZONA ELASTOMER REPAIRS TO AGITATOR IN FGD UNIT

ID: 927

Customer Location: Power Station, Lawrence, Kansas

Application Date: September 2007

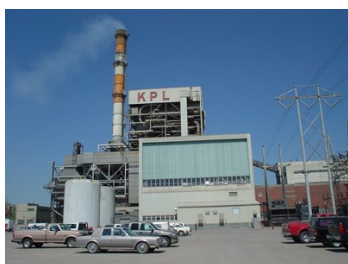
- * General view of the plant ,
- * The Crystallization Tank Mixer ,
- * Application crew in action ,
- * Completed application ,

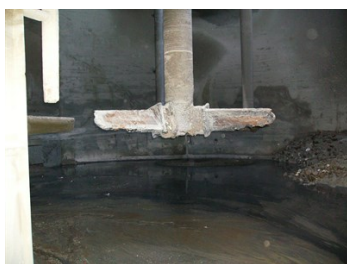
Rubber clad blades damaged through impact and abrasion. Each shaft has three blades and there were four shafts.

Agitator blades in crystallization tank which is an important component of the Flue Gas Desulfurization (FGD) unit.
