# Belzona protects bund area subject to chemical attack.

**Industry:** General Industry  
**Application:** FPA-Floor Problem Areas  
**Substrate:** Concrete  
**Products:** Belzona 4131 (Magma-Screed), Belzona 4911 (Magma TX Conditioner), Belzona 5811 (Immersion Grade)

**Customer Location:** Portlaois, Ireland  
**Application Date:** February 2024

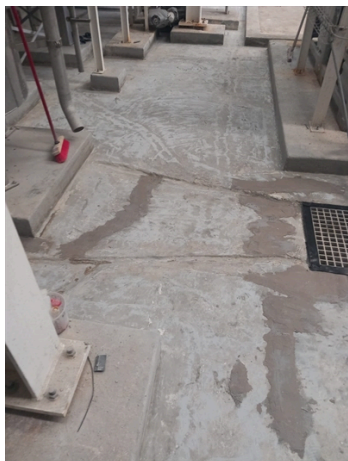
Cracks in concrete of bund area

Previous coating of bund had failed due to contact with Ammonium Sulphate, causing significant damage to concrete in bund area. Customer choose Belzona after a recommendation from a colleague who had experience with Belzona in a previous role.

- Grinder with diamond blade used to produce a stable, firm surface suitable for lining.
- Belzona 4911 used as a primer.
- Belzona 4131 used to rebuild and repair honeycombing and blowholes in concrete.
- Belzona 5811 chosen as floor coating due to excellent resistance to Ammonium Sulphate.

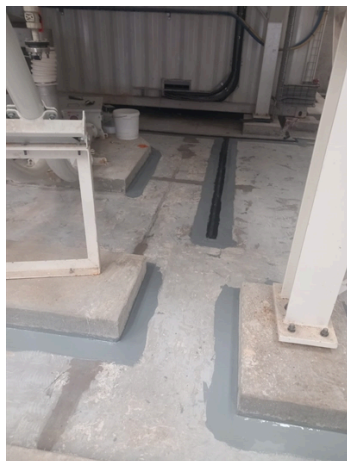
Prepared edges of plinths

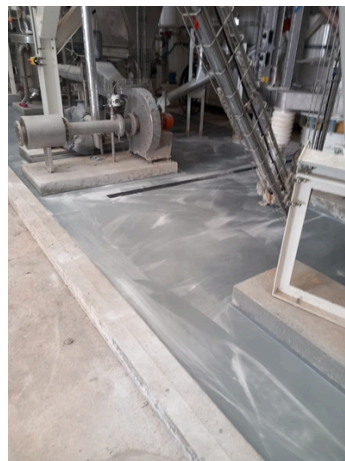
First coating

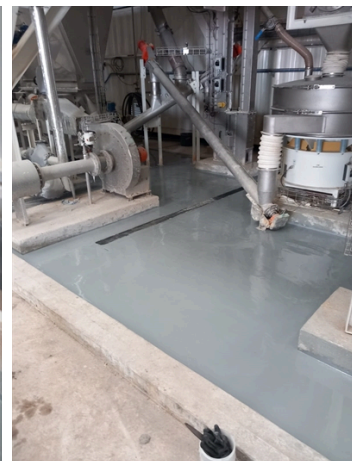
Finished surface
