Belzona protects bund area subject to chemical attack.

ID: 9273

Industry: General Industry
Application: FPA-Floor Problem Areas
Substrate: Concrete
Products: Belzona 4131 (Magma-Screed), Belzona 4911 (Magma TX Conditioner), Belzona 5811 (Immersion Grade)

Customer Location: Portlaois, Ireland
Application Date: February 2024

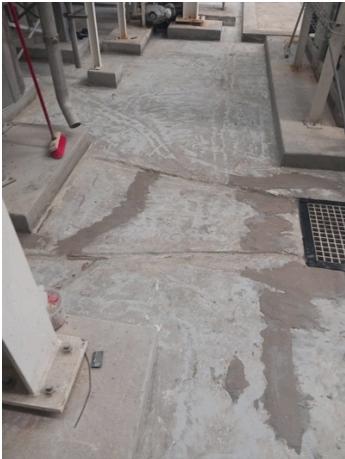
Cracks in concrete of bund area Prepared edges of plinths

Previous coating of bund had failed due to contact with Ammonium Sulphate, causing significant damage to concrete in bund area. Customer choose Belzona after a recommendation from a colleague who had experience with Belzona in a previous role.

- Grinder with diamond blade used to produce a stable, firm surface suitable for lining.
- Belzona 4911 used as a primer.
- Belzona 4131 used to rebuild and repair honeycombing and blowholes in concrete.
- Belzona 5811 chosen as floor coating due to excellent resistance to Ammonium Sulphate.

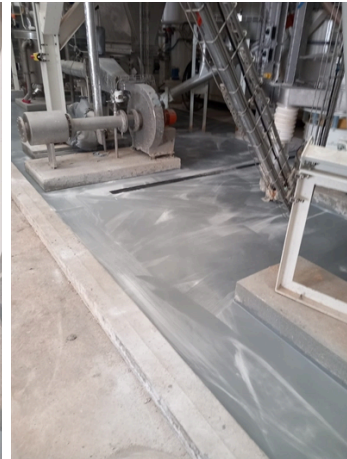
First coating

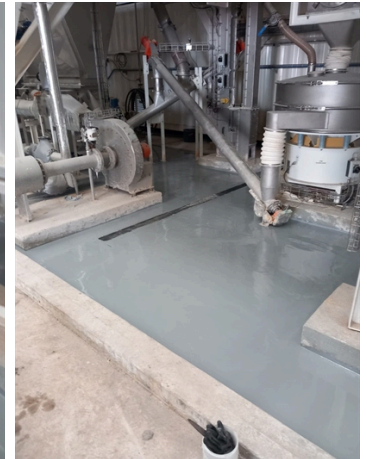
Finished surface
