Belzona System Protects Ebonite Tanks

ID: 9281

Industry:	Other	Customer Location:	France
Application:	TCC-Tanks and Chemical Containment Areas	Application Date:	
Substrate:	Other		
Products:	Belzona 1111 (Super Metal), Belzona 1392 (Ceramic HT2), Belzona 1981 (SuperWrap II)

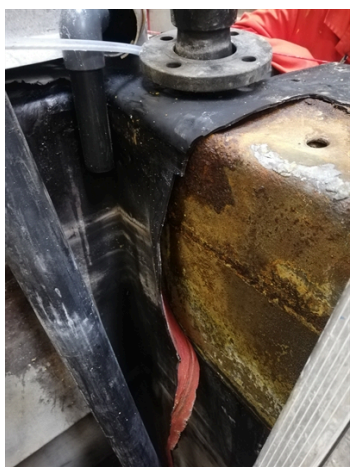
A global aluminium manufacturing company has been experiencing degradation to their Ebonite-coated steel tanks which were subject to chemical attack in the form of sulphuric acid. The acid had caused the ebonite to break down and then create holes in the tank.

Ebonite tank suffering from degradation

A combination of different Belzona products has been recommended to offer the best solution for the repair. Belzona 1111 for resurfacing the substrate back to original profile where it has been damaged by corrosion and chemical attack, Belzona 1981 and Belzona 9371 for reinforcing the substrate with fibreglass where the wall was too thin or had holes, and Belzona 1392 for protection from further damage of the same kind. This combination was chosen because it is resistant to 30% concentrated sulphuric acid, but also because Belzona 1392 can resist higher temperatures in case of spikes and can be applied in a thicker coat. Important key points for the client were also the speed of the repair (they could only afford limited downtime and the Belzona solution could be applied in only 3 or 4 days), the durability of the repair and low cost.

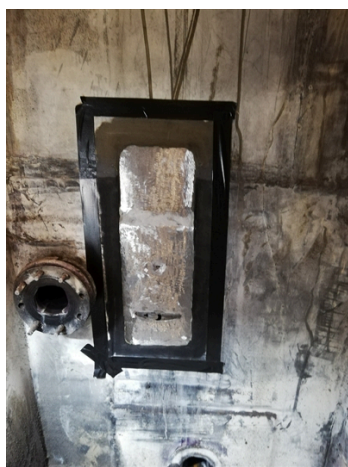
Surface prepared and area taped off, ready for application

To apply the products, the damaged existing coating had to be removed and the surface grinded to Swedish Standard Sa 2½ and minimum profile of 75µ.

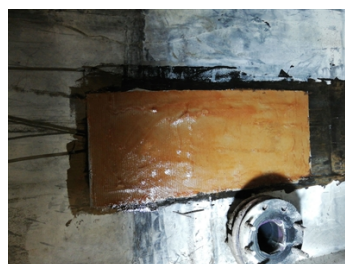
Finished application
