# Belzona System Protects Ebonite Tanks

Industry: Other  
Application: TCC-Tanks and Chemical Containment Areas  
Substrate: Other  
Products: Belzona 1111 (Super Metal), Belzona 1392 (Ceramic HT2), Belzona 1981 (SuperWrap II)

Customer Location: France  
Application Date:

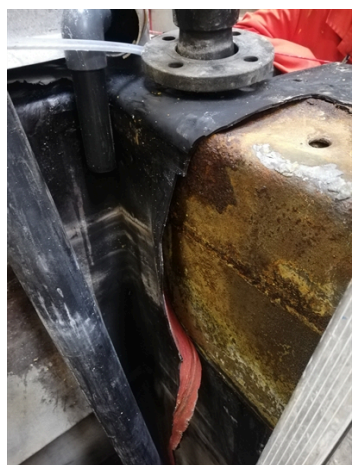
A global aluminium manufacturing company has been experiencing degradation to their Ebonite-coated steel tanks which were subject to chemical attack in the form of sulphuric acid. The acid had caused the ebonite to break down and then create holes in the tank.

Ebonite tank suffering from degradation

A combination of different Belzona products has been recommended to offer the best solution for the repair. Belzona 1111 for resurfacing the substrate back to original profile where it has been damaged by corrosion and chemical attack, Belzona 1981 and Belzona 9371 for reinforcing the substrate with fibreglass where the wall was too thin or had holes, and Belzona 1392 for protection from further damage of the same kind. This combination was chosen because it is resistant to 30% concentrated sulphuric acid, but also because Belzona 1392 can resist higher temperatures in case of spikes and can be applied in a thicker coat. Important key points for the client were also the speed of the repair (they could only afford limited downtime and the Belzona solution could be applied in only 3 or 4 days), the durability of the repair and low cost.

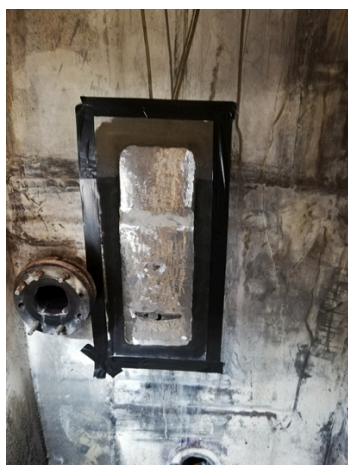
Surface prepared and area taped off, ready for application

To apply the products, the damaged existing coating had to be removed and the surface grinded to Swedish Standard Sa 2½ and minimum profile of 75µ.

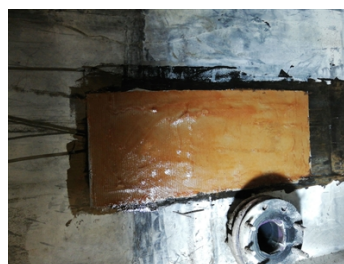
Finished application
